S19. (1) Flood Investigation Report

Warrington Borough Council – Lead Local Flood Authority

Location: Cromwell Avenue, Callands

Flood Investigation Reference Number: 2012/006b

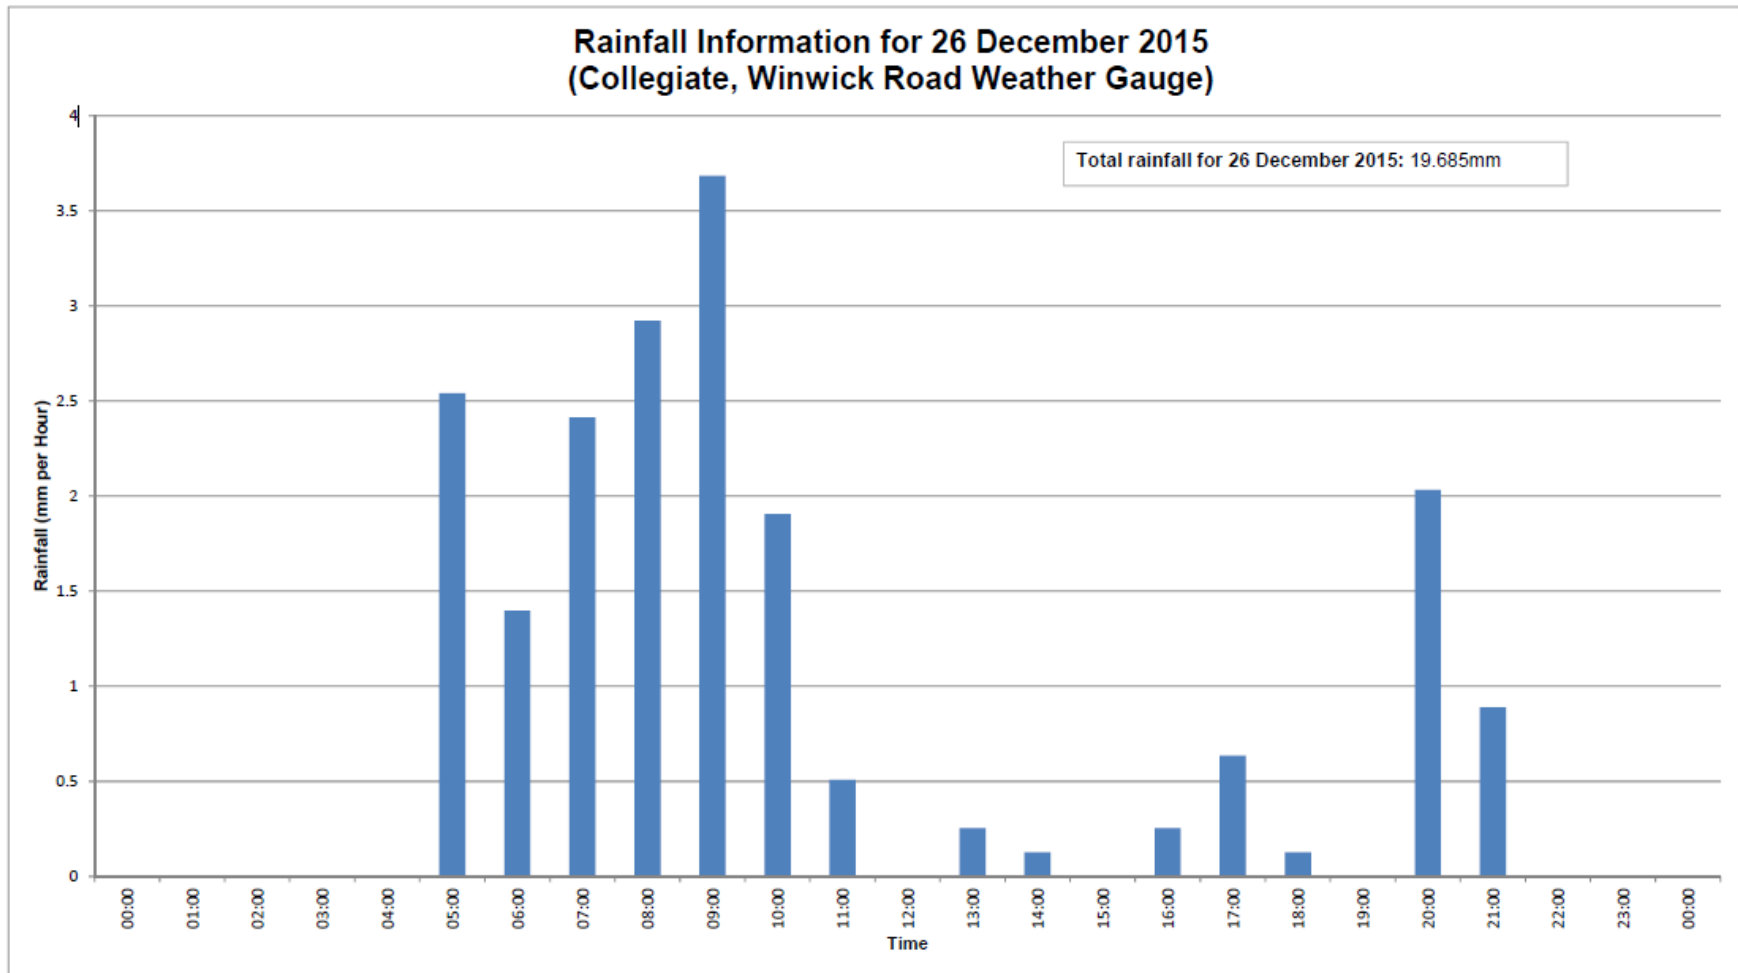
Figure 1: Rainfall information.

19.685mm of rain fell on the Warrington Borough Council rain gauge at the Collegiate, Long Lane from 05:00 to 21:00 on 26 December 2015. (See figure 1.)

The rainfall data shows that no rain fell on 27 December 2015.

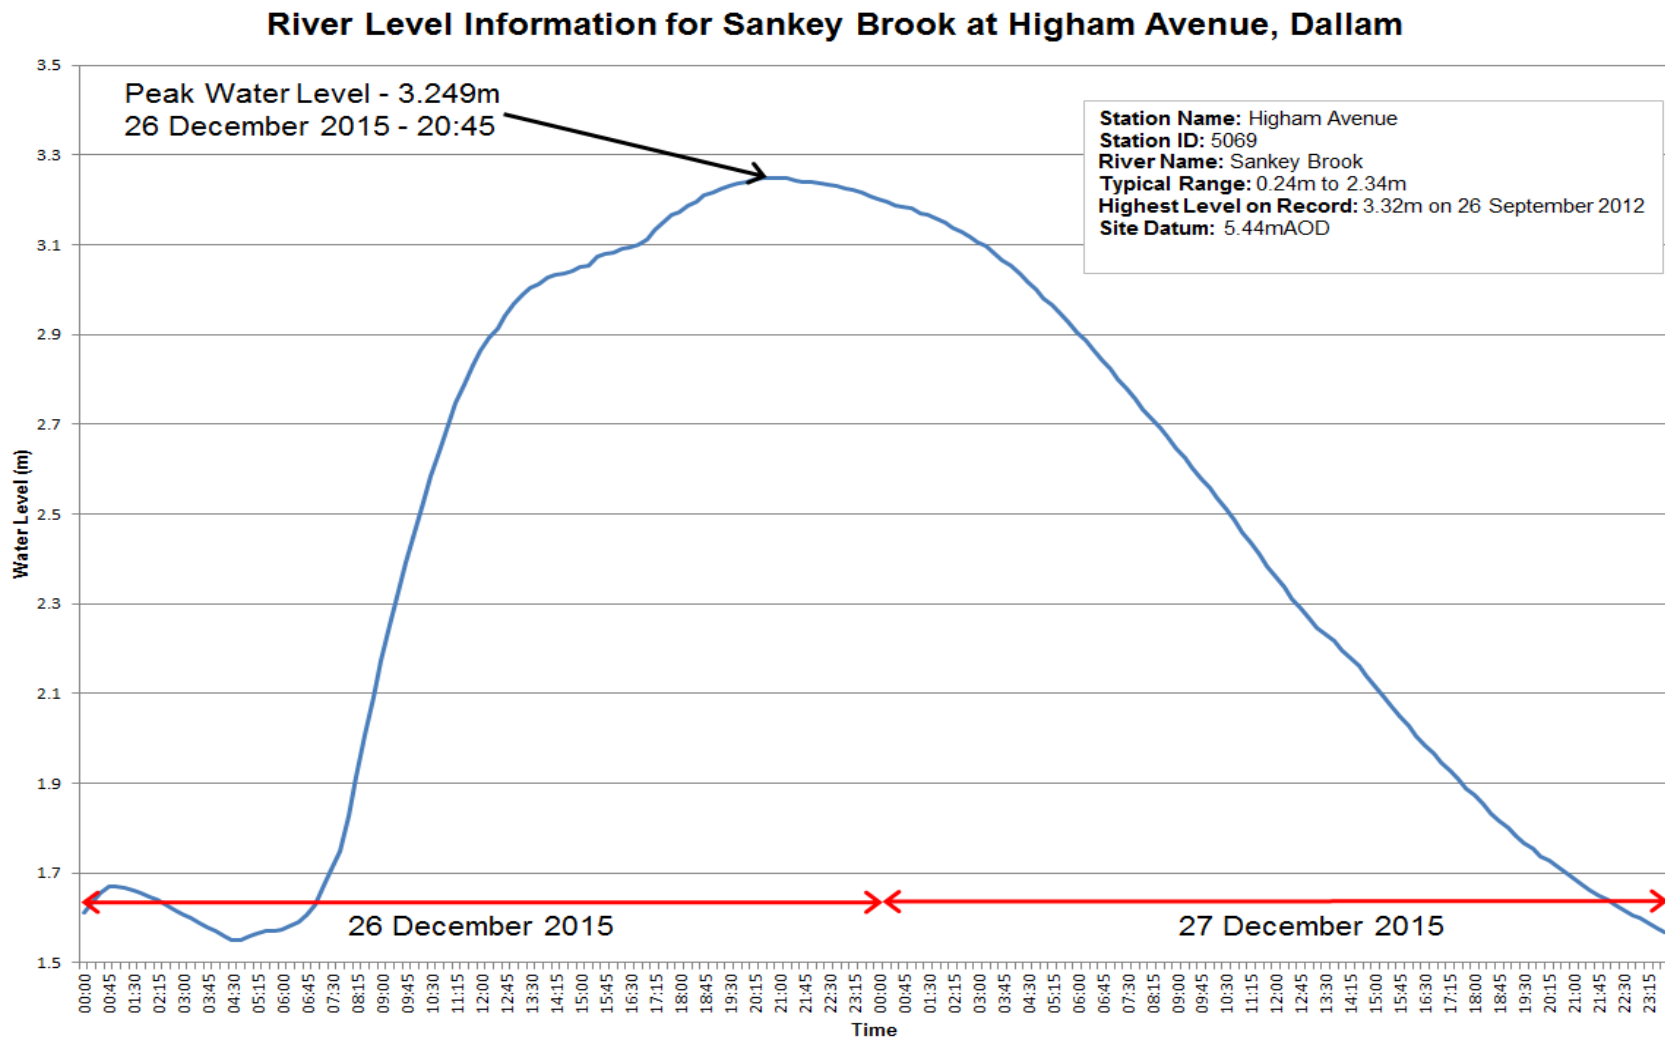
Figure 2: EA River Level Telemetry Reading at Higham Avenue.

The peak water level for this flood event for the Sankey Brook at Higham Avenue, Dallam was 3.249m and it occurred on 26 December 2015 at 20:45. This is 71mm lower than the previously highest recorded level. The river level information is shown in Figure 2.

The highest recorded level for the telemetry station was observed during the event on 26 September 2012 at 3.32m. This coincides with previous reported flooding.

It should be noted that high river levels can cause surface water systems which are drained by gravity to fail to discharge or not operate efficiently as their outfalls are blocked or flap valves are closed to prevent river water entering the system and exacerbating the situation.
