S19. (1) Flood Investigation Report

Date: May 2016

Location: Stone Pit Lane, Croft

Flood Investigation Reference Number: 2016/008/001

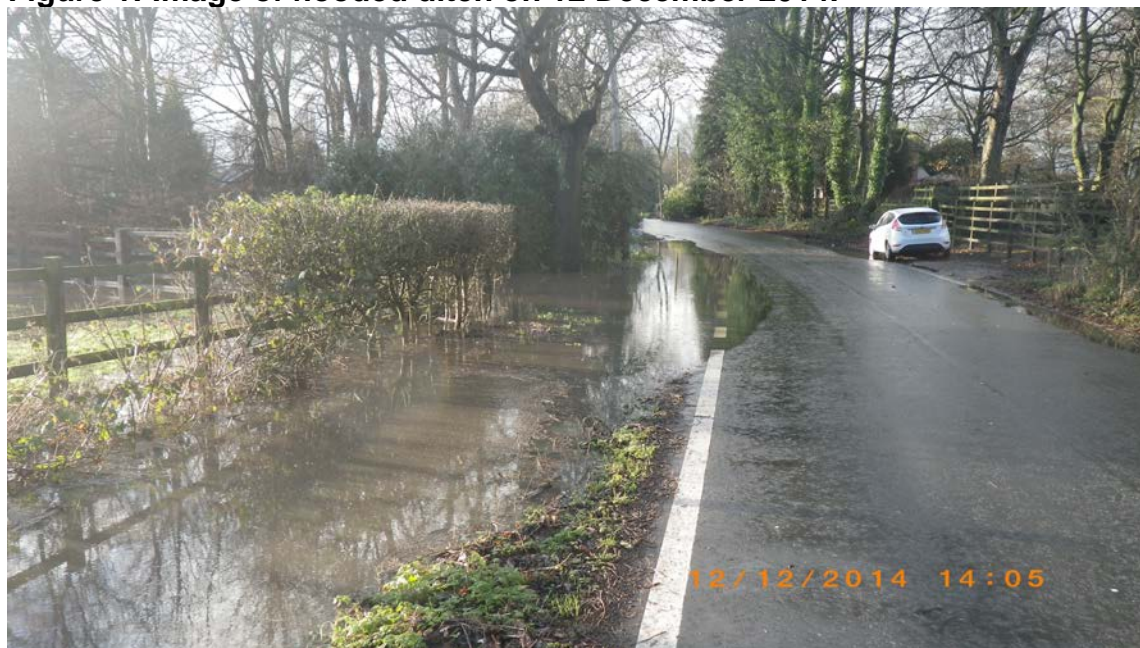
The Council is aware that flooding occurred to the carriageway on Stone Pit lane on 12 December 2014 which affected the entrance to Turret Hall and the Stables (See figure 1 below). The flood event was attended by Mr Jonathan Dawson-Parry (Asset & Flood Risk Engineer - Warrington Borough Council).

The cause of flooding was identified as a blockage of the inlet to a culvert due to vegetation growth. Removal of the vegetation was undertaken by the Highway Maintenance Team.

Figure 1: Image of flooded ditch on 12 December 2014.

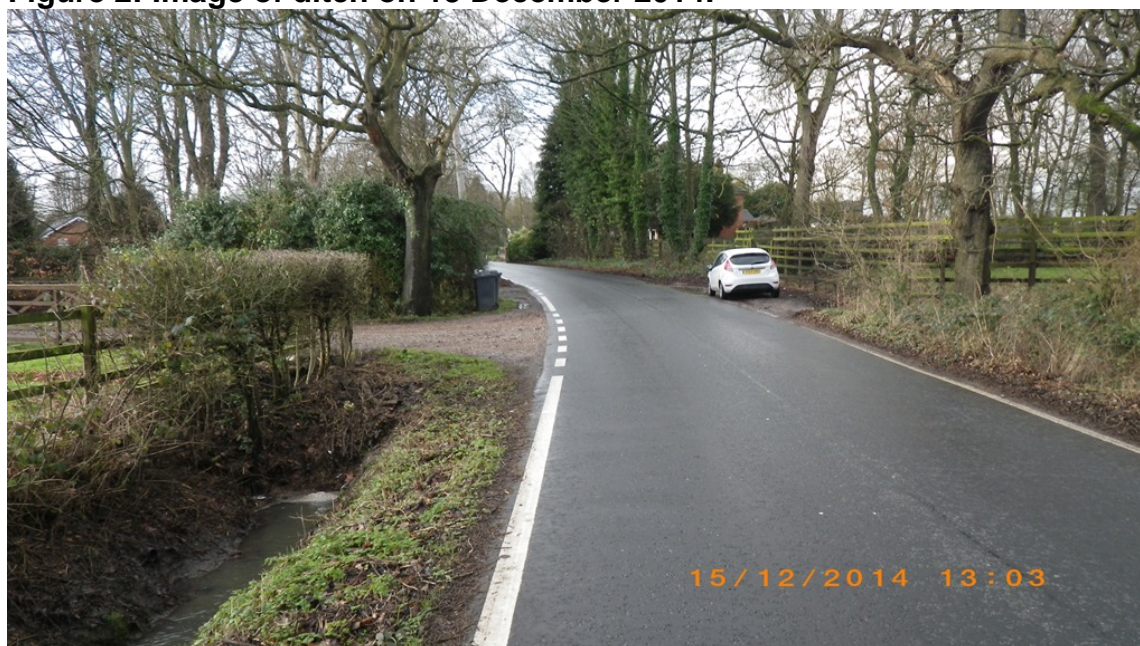
A further inspection was undertaken by Mr Jonathan Dawson-Parry on 15 December 2014 where it was observed that the flood water had receded (See figure 2 below).

Figure 2: Image of ditch on 15 December 2014.

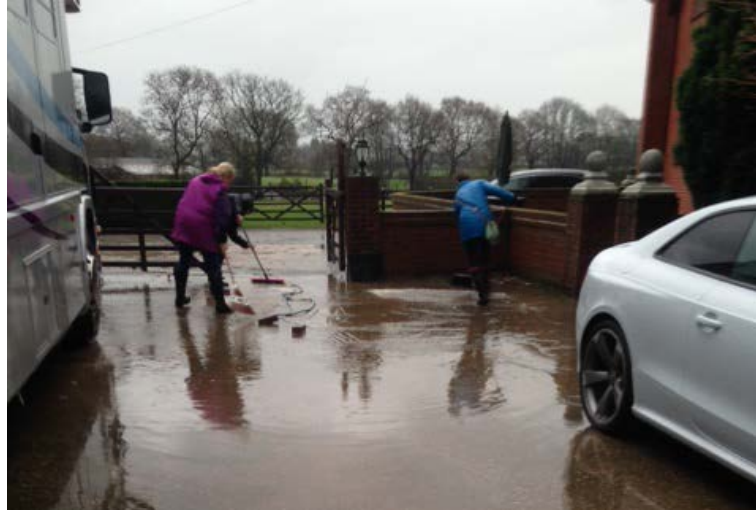
Warrington Borough Council is aware that 1 business was flooded.

Figure 3: Image of flooding on 26 December 2015 to stable yard provided by resident.

It is the conclusion of Warrington Borough Council that the flooding which occurred on 26 December 2015 to “The Stables” would appear to have been due to surface water runoff from the surrounding fields.

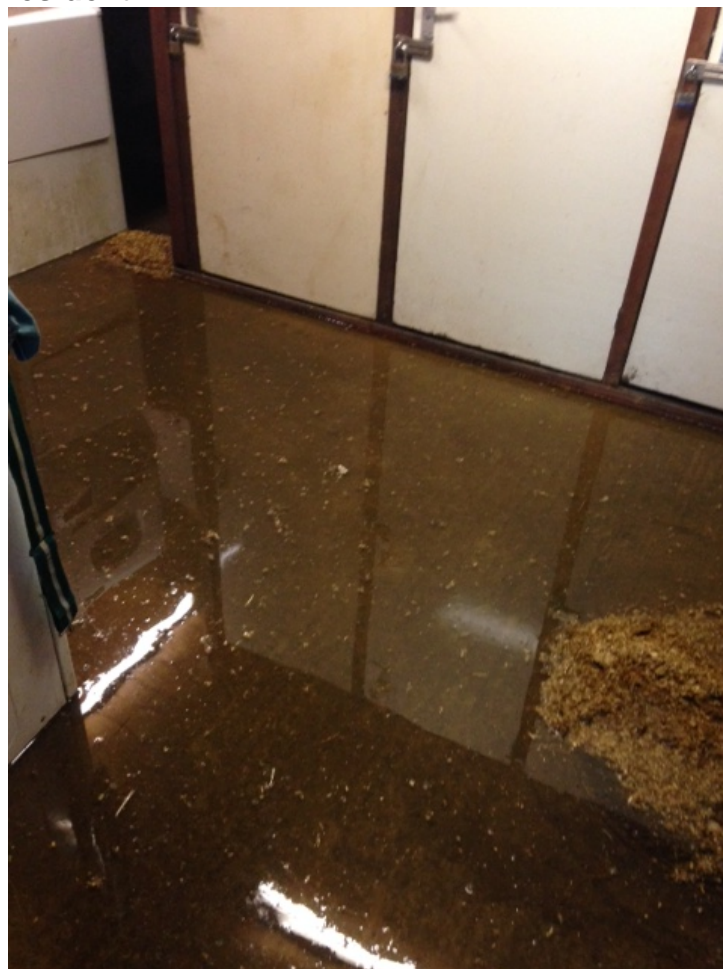
Figure 4: Image of flooding on 26 December 2015 to stable block provided by resident.

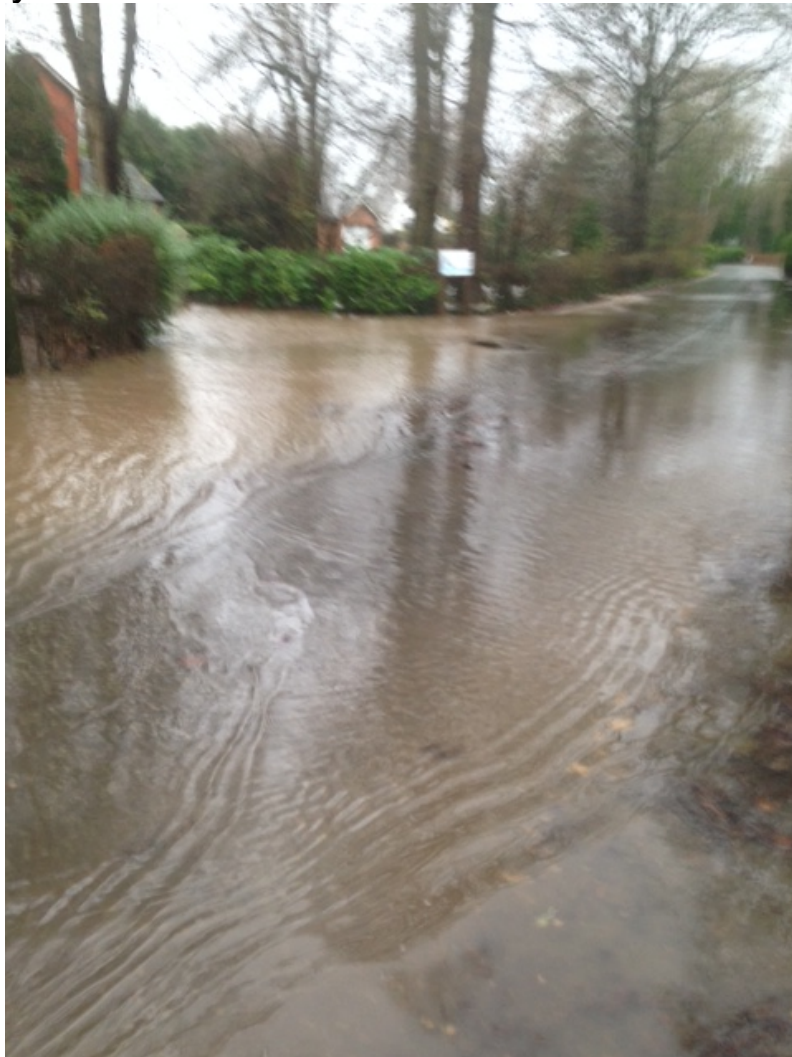
It should be noted that Stone Pit Lane was severely affected by flooding (See figure 5 below).

Figure 5: Image of flooding on 26 December 2015 to Stone Pit Lane provided by resident.

It is the conclusion of Warrington Borough Council that the flooding which occurred on 26 December 2015 to Stone Pit Lane and the accesses to “The Stables” and “Turret Hall” would appear to have been due to blockage of the culvert from the drainage ditch to the outfall into Cockshot Brook causing the ditch to overflow. It may also be that the water level was high in Cockshot Brook further reducing the efficiency of the drainage system as well as excessive overland flow entering the system.

- Jet culvert to remove blockages.
- Root cut culvert.
- Install manhole to improve access.
- Install headwall at inlet to culvert.
- Confirm alignment of watercourse and confirm appropriate riparian owner.

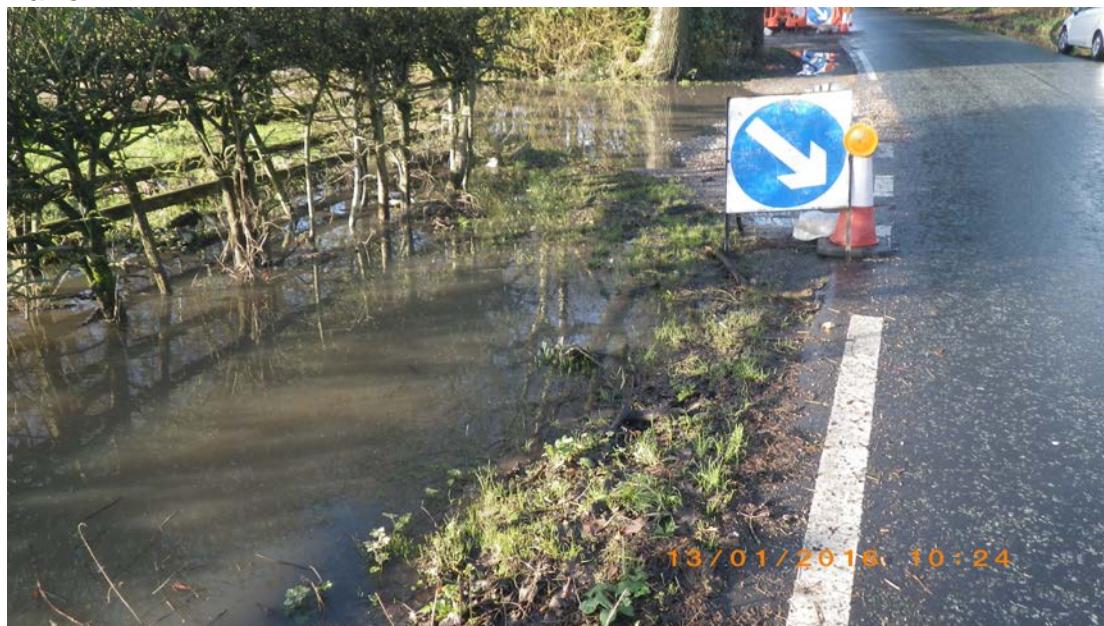
The above Officers witnessed that the water level in the ditch was still high and the entrance to The Stables and Turret Hall were still flooded.

Figure 6: Image of flooding observed on 13 January 2016 to Stone Pit Lane.

Prior to this, the issue was dealt with by the Highway Maintenance Team whom had dug down on the culvert adjacent to the entrance to Turret Hall in order to gain access to try and clear the blockage.

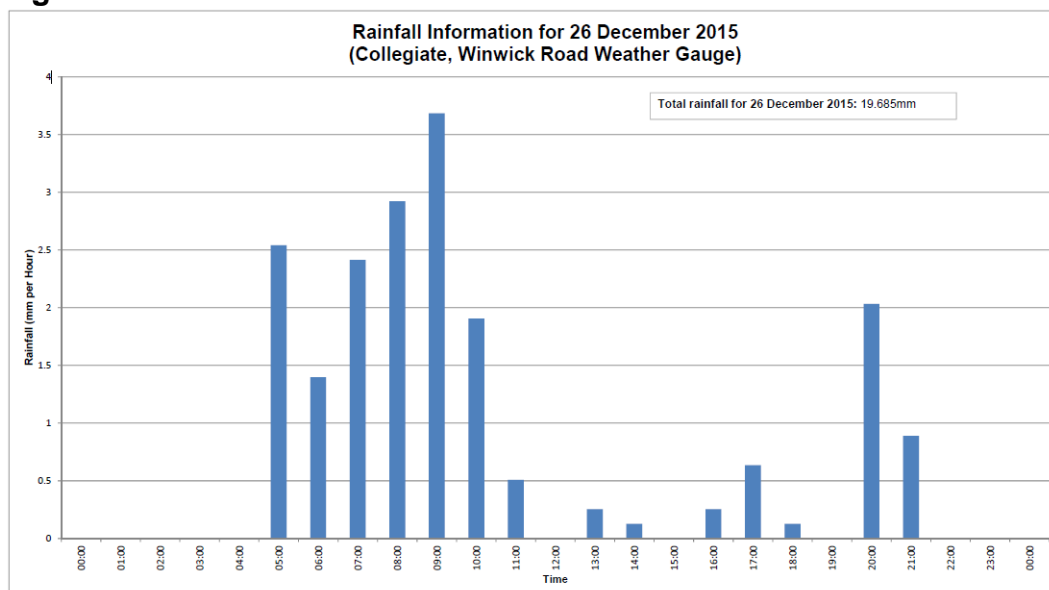
19.685mm of rain fell on the Warrington Borough Council rain gauge at the Collegiate from 05:00 to 21:00 on 26 December 2015. (See figure 8)

Figure 8: Rainfall information.

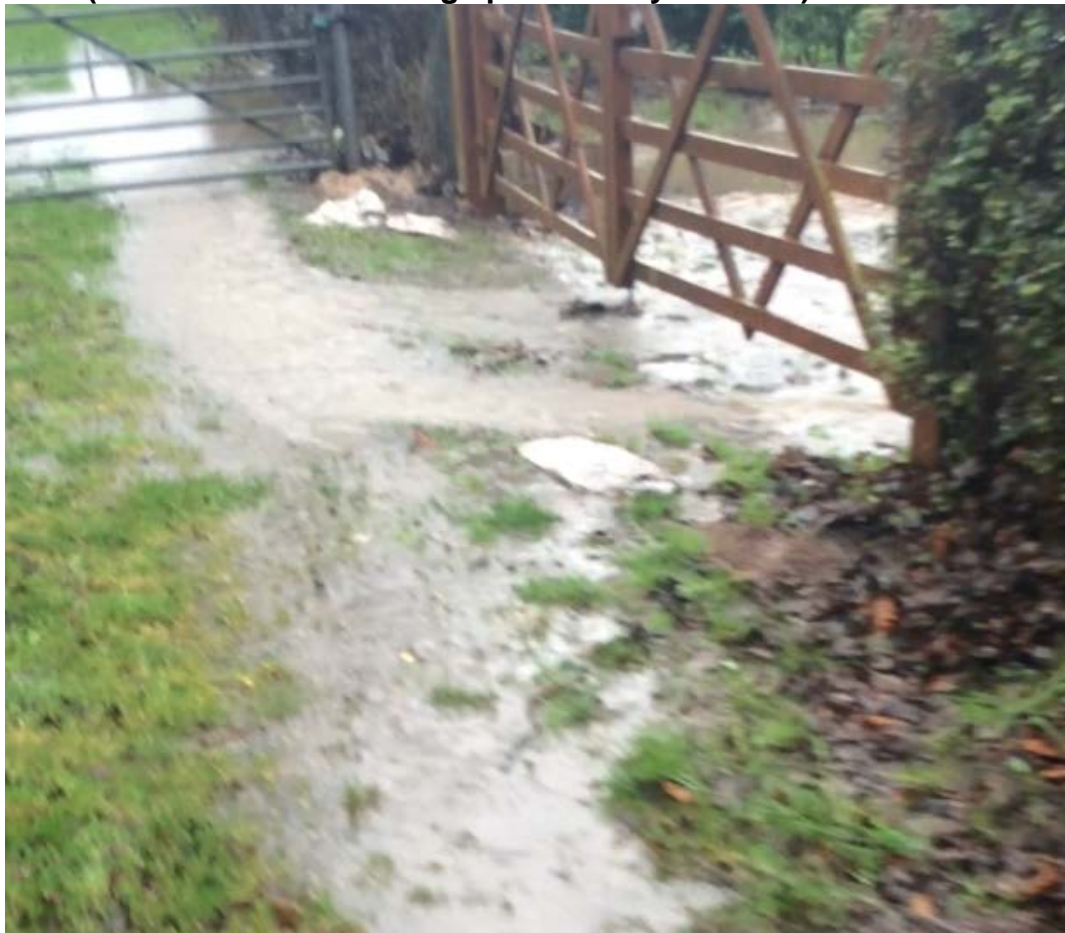
Significant amounts of overland flow were observed on Heath Lane as can be seen in figure 9 & 10 (approx. 450m east from the affected area on Stone Pit Lane) on 26 December 2015 (Video provided by resident of Heath Lane).

Figure 9: Image showing overland flow at Heath Lane on 26 December 2015 (taken from video footage provided by resident).

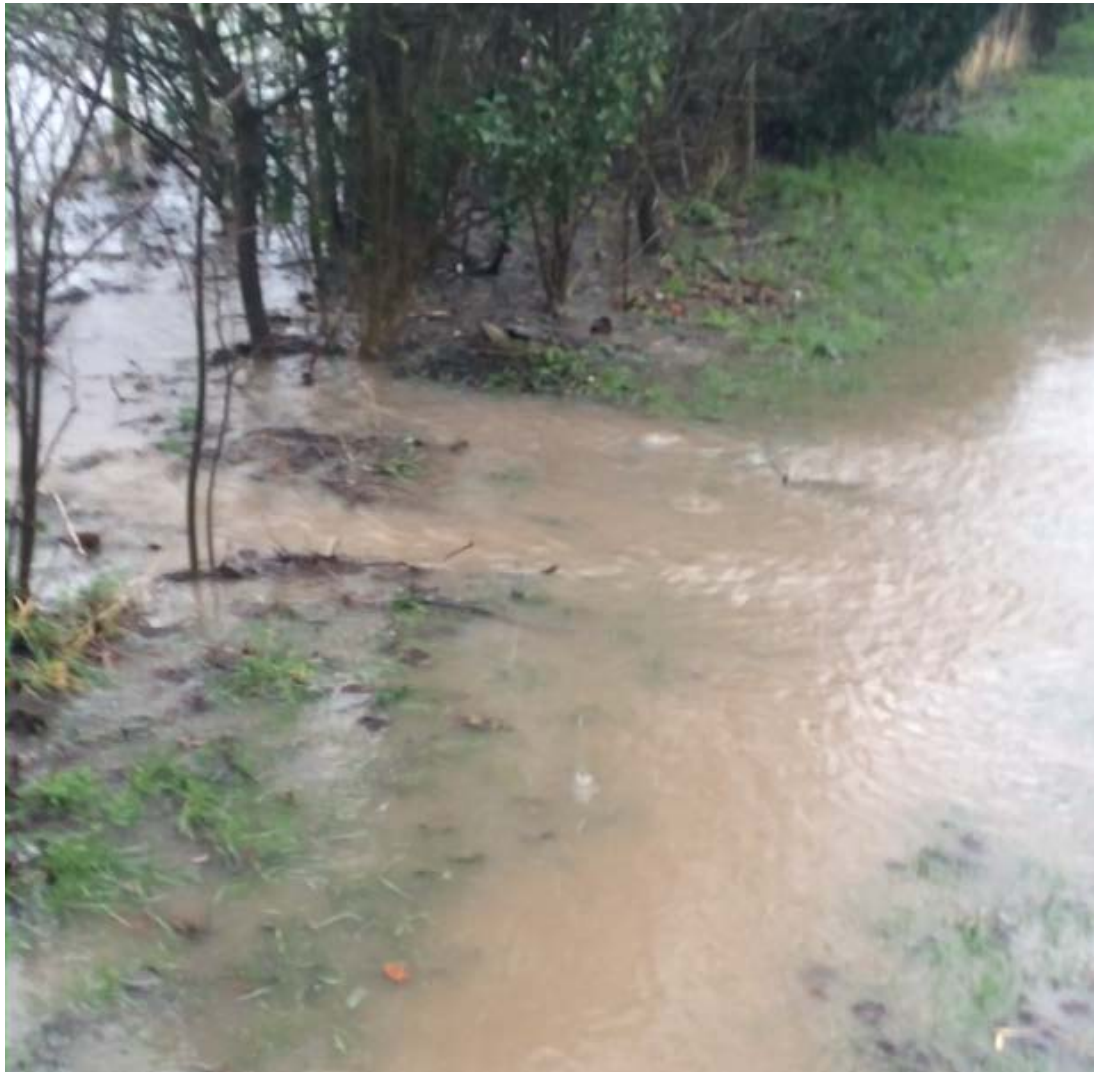
Figure 10: Image showing overland flow at Heath Lane on 26 December 2015 (taken from video footage provided by resident).

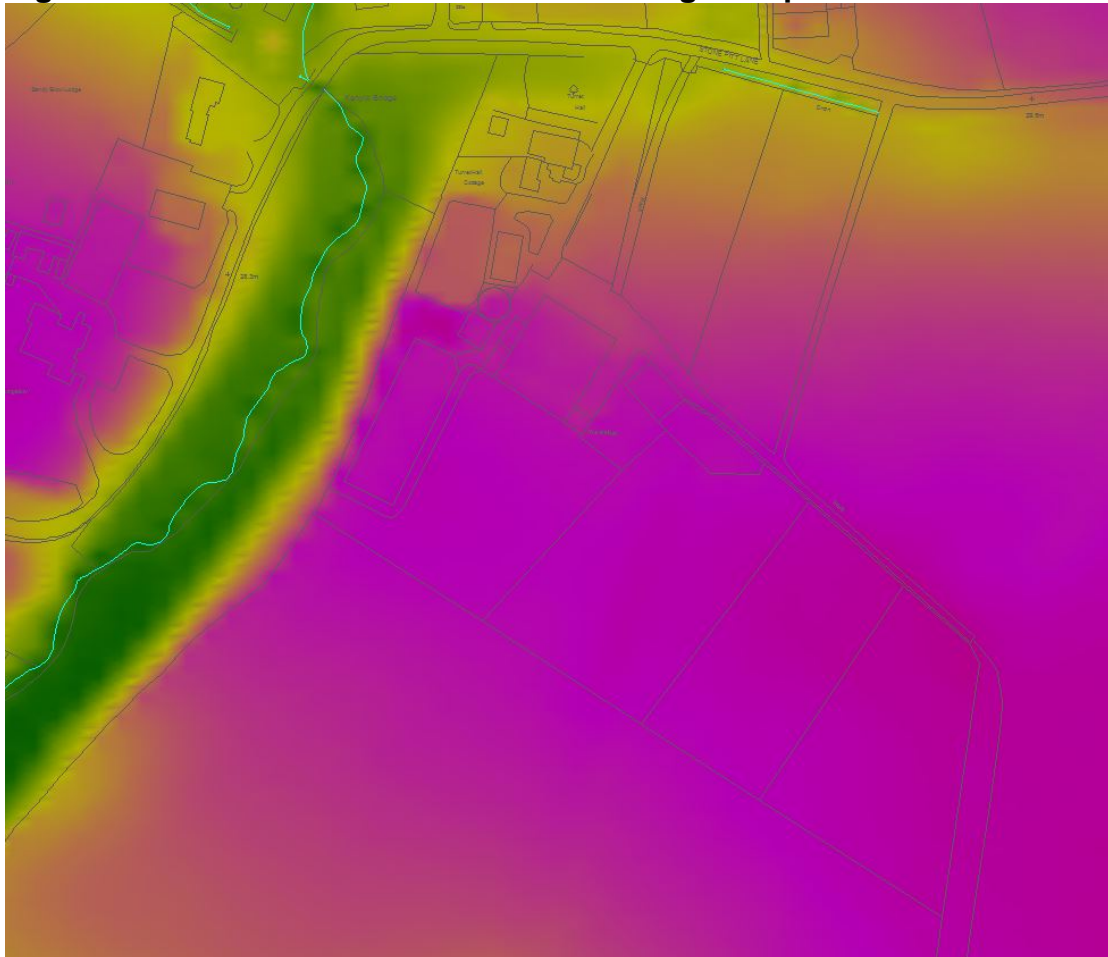
It appears that the surrounding land slopes generally in an east to west direction towards Cockshot Brook.

It should be noted that the entrance to Turret Hall/The Stables is approximately 3.5metres lower than the stables where internal business

flooding occurred and is a localised low spot. It is shown as being at high risk on the Environment Agency Risk of Flooding from Surface Water Mapping.

Figure 11: Lidar Data shown as coloured height map.

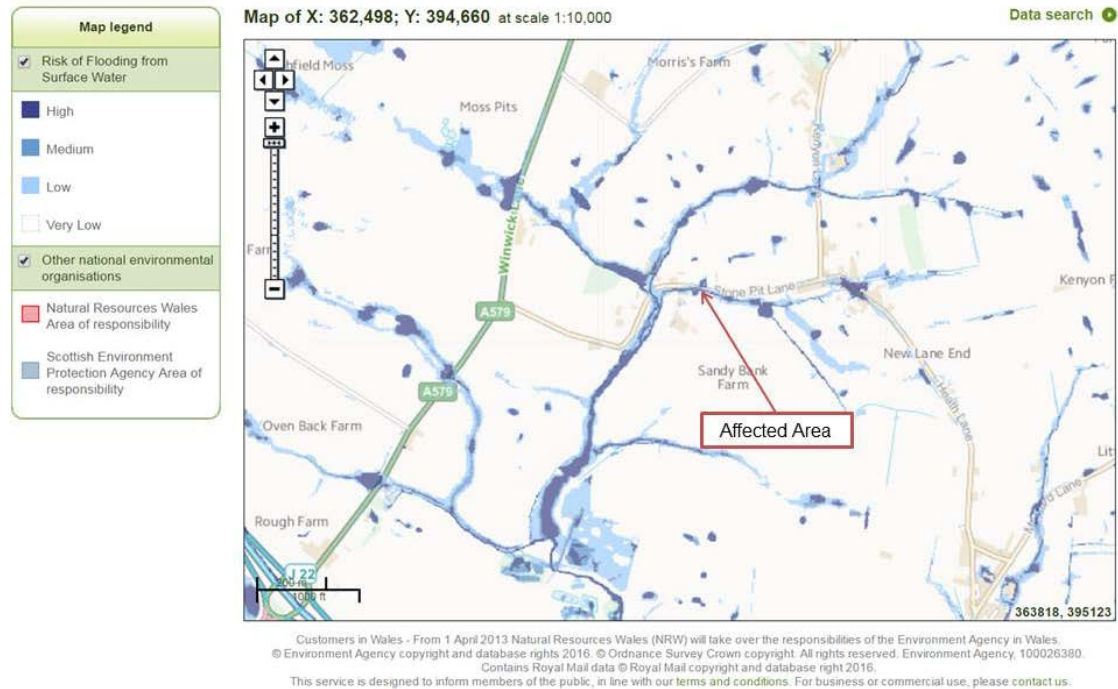
Figure 12: Extract of Environment Agency Risk of Flooding from Surface Water Mapping.

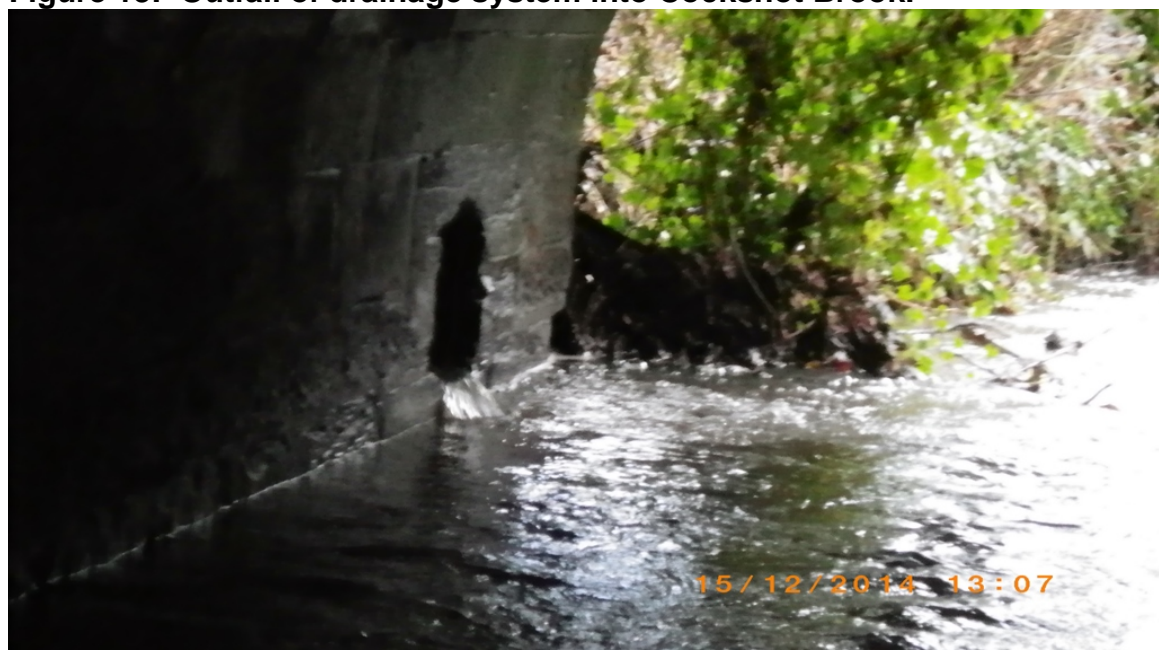
there appears to be no non-return mechanism on the outfall from the culverted section of watercourse into Cockshot Brook. This may result in water backing up the culvert during times of high flow on Cockshot Brook.

Downstream the ditch is culverted through to an outfall located within the abutment of Kenylo Bridge into Cockshot Brook approximately 120m to the west of the flooding area.

Figure 13: Outfall of drainage system into Cockshot Brook.
