S19. (1) Flood Investigation Report

Date: January 2016

Location: A562 Widnes Road, Penketh

Flood Investigation Reference Number: 2012/010

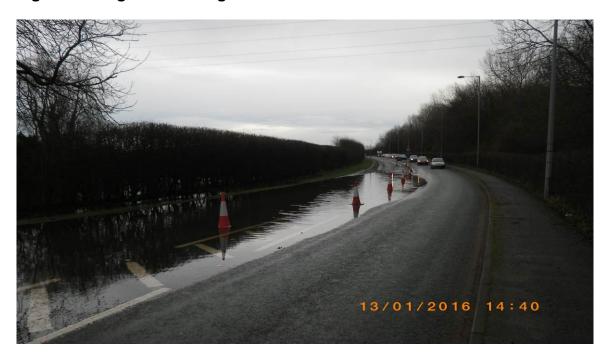
Figure 1: Image of Flooding to A562 Widnes Road.

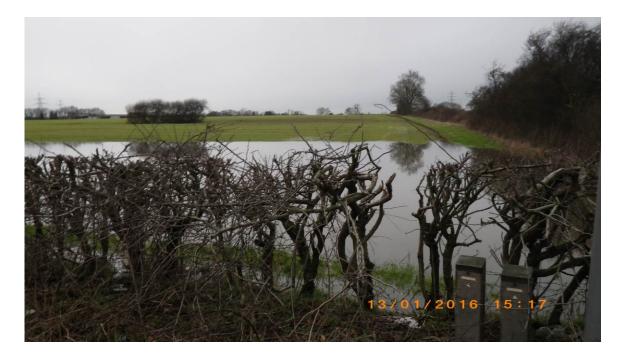
Figure 2: Image of Flooding to Agricultural Land adjacent to A562 Widnes Road.

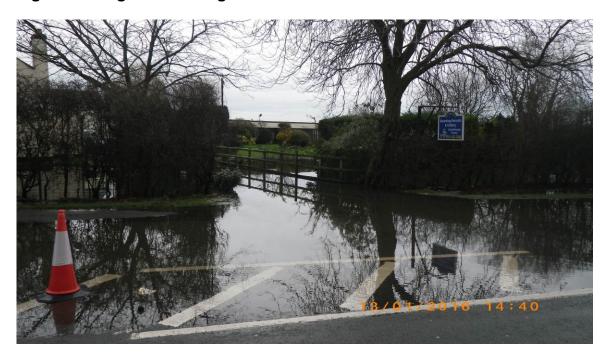
Figure 3: Image of Flooding to Entrance of Rose Tree Farm.

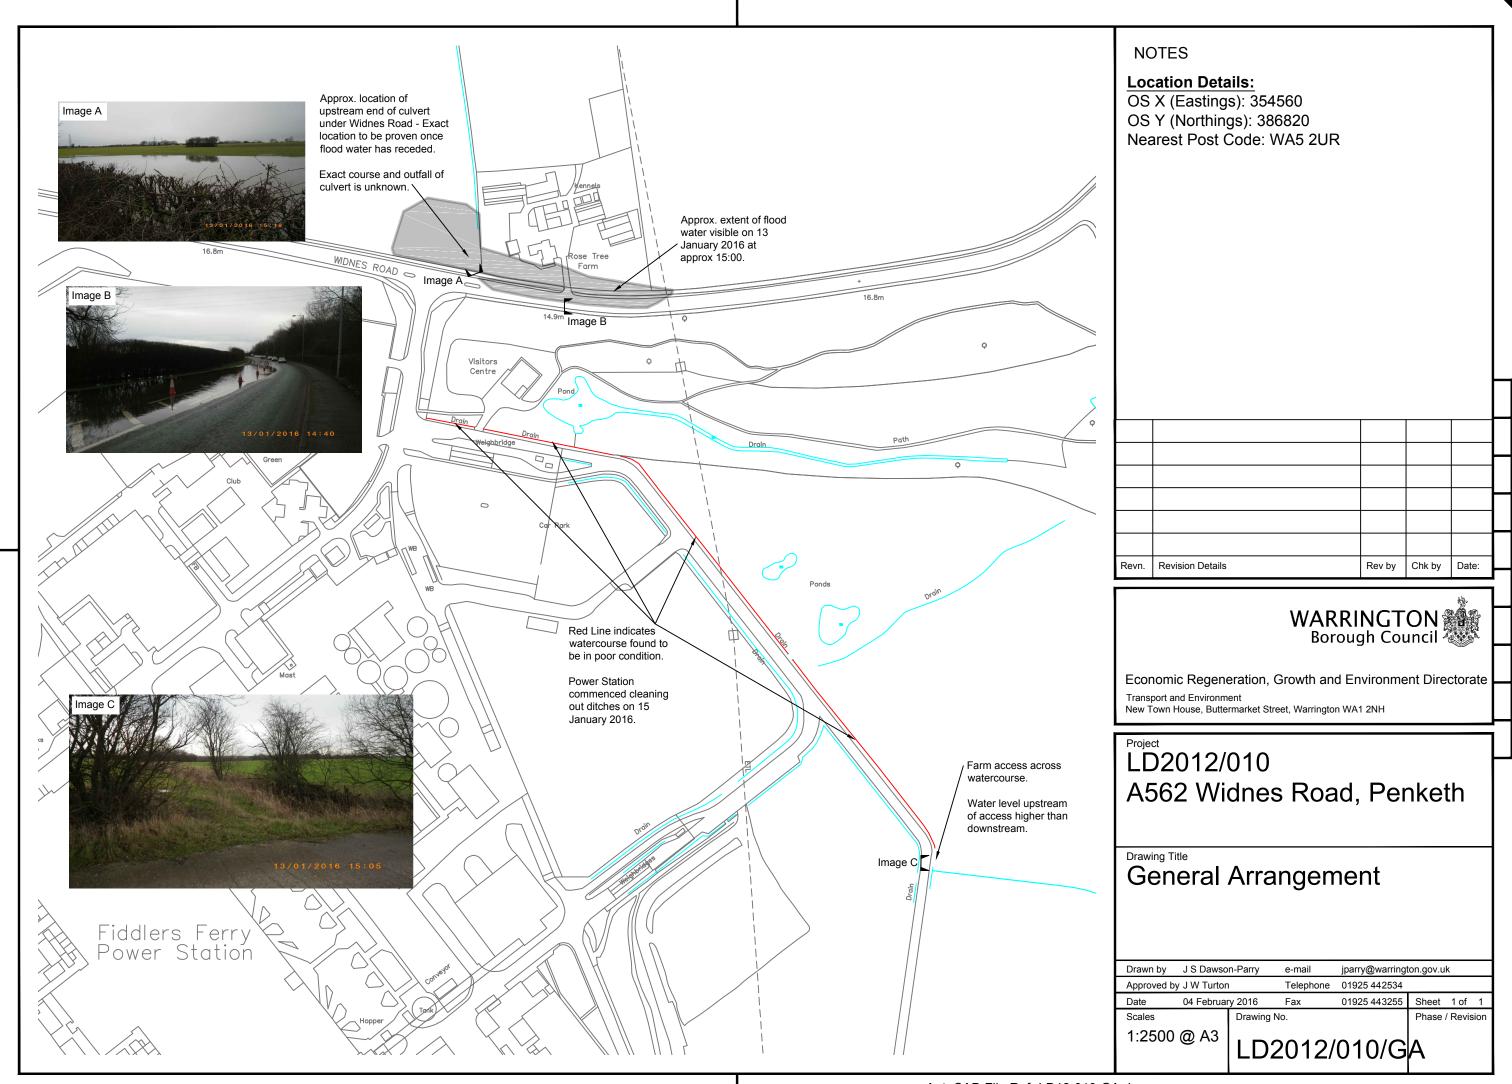
Drawing Number: LD2012/010/GA – General Arrangement

It was identified during the site visit on 13 January 2016 that the drainage ditches adjacent to an access road at Fiddlers Ferry power station were in poor condition (shown in red on drawing no. LD2012/010/GA).

It was also identified at a farm access into a field next to the access road that the water level upstream was higher than the water level downstream indicating that the culvert under the field access had either collapsed or was blocked. (Exact location shown on drawing no. LD2012/010/GA).

The power station site manager agreed to clean the ditches out and investigate the blockage/collapse of the culvert under the field access. Work commenced on 15 January 2016.
