S19. (1) Flood Investigation Report

Warrington Borough Council – Lead Local Flood Authority

Location: Thelwall / Lymm

Flood Investigation Reference Number: 2016/006/001

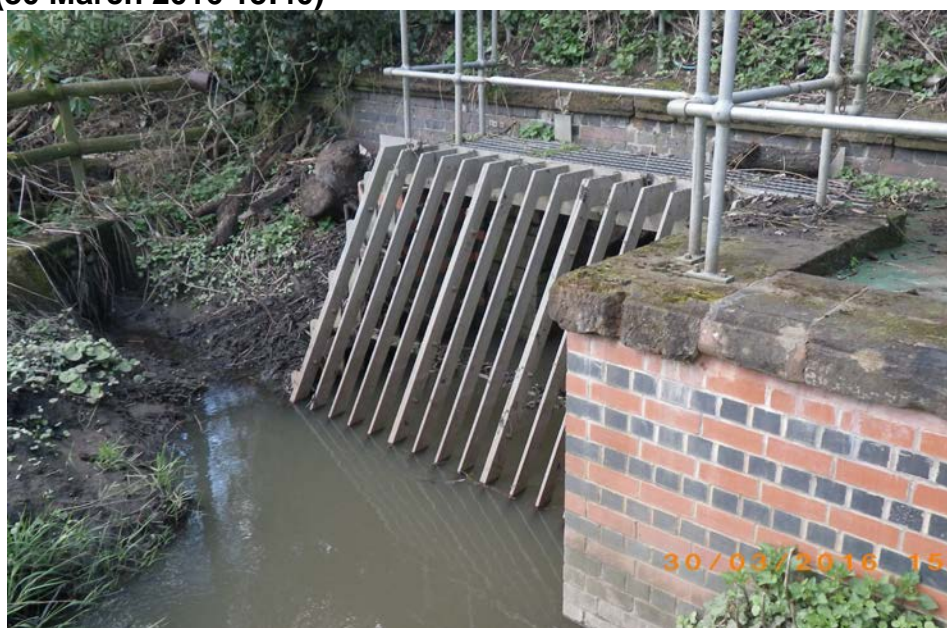
Figure 1: Trash Screen on Thelwall Brook at inlet to siphon under the River Mersey. (30 March 2016 15:40)

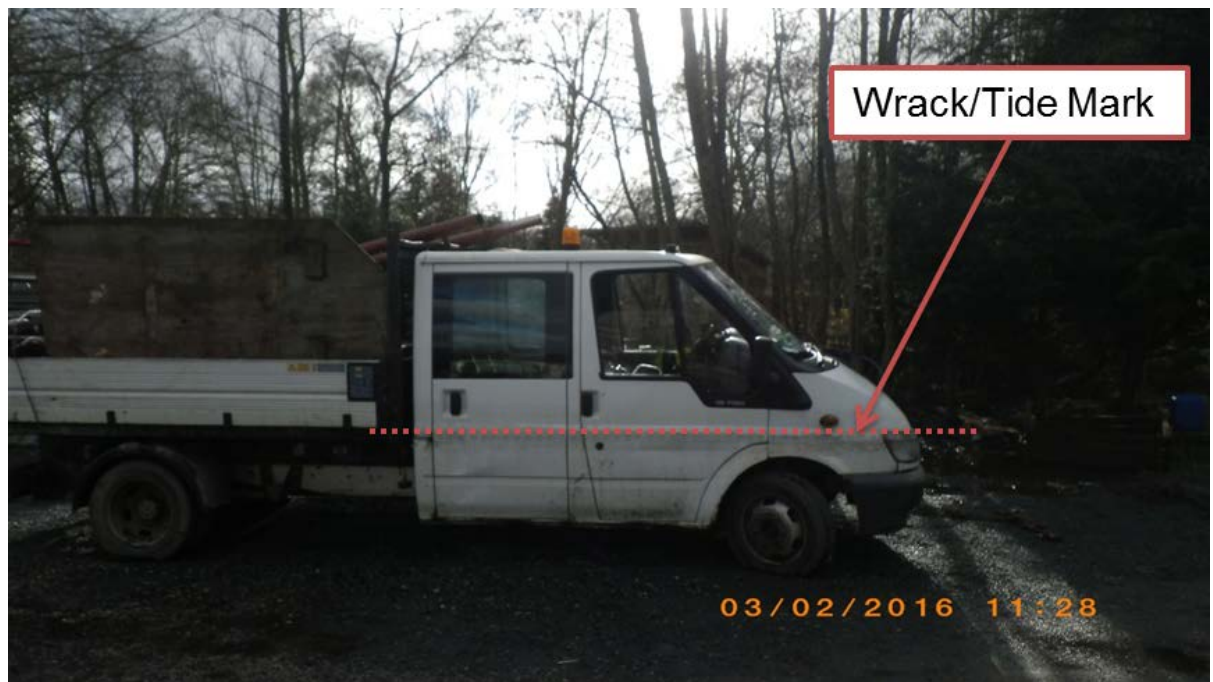
The estimated peak flood level for the flood event which occurred on 26 December 2015 is 9.189m AOD (Above Ordinance Datum) at Caddicks Nursery achieving a depth of approximately 0.9m.

Figure 2: Example of observed wrack/tide mark. (03 February 2016 11:28)

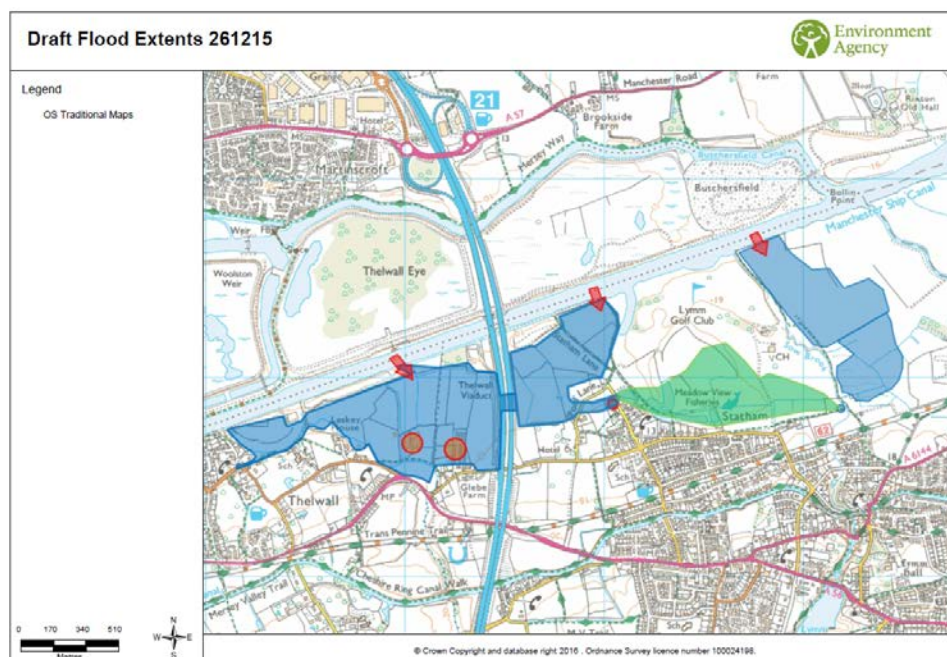
A site visit and data gathering was undertaken by the Environment Agency in the first weeks of January. This found that water left the canal in at least three locations. The indicative breach locations are shown on drawing no. LD2016/006/001 and on the drawing provided to Warrington Borough Council by Environment Agency in figure 3 below.

Figure 3: Flood Extents and Breach Locations.

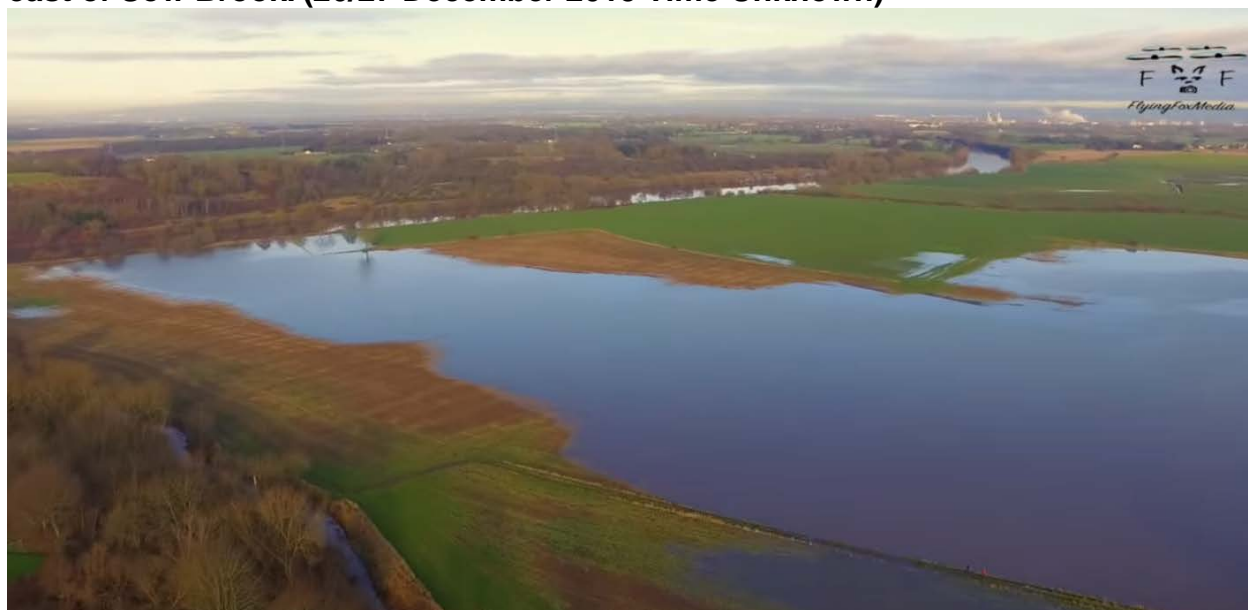
Figure 4: Image from Flying Fox Media which shows water escaping the canal east of Sow Brook. (26/27 December 2015 Time Unknown)

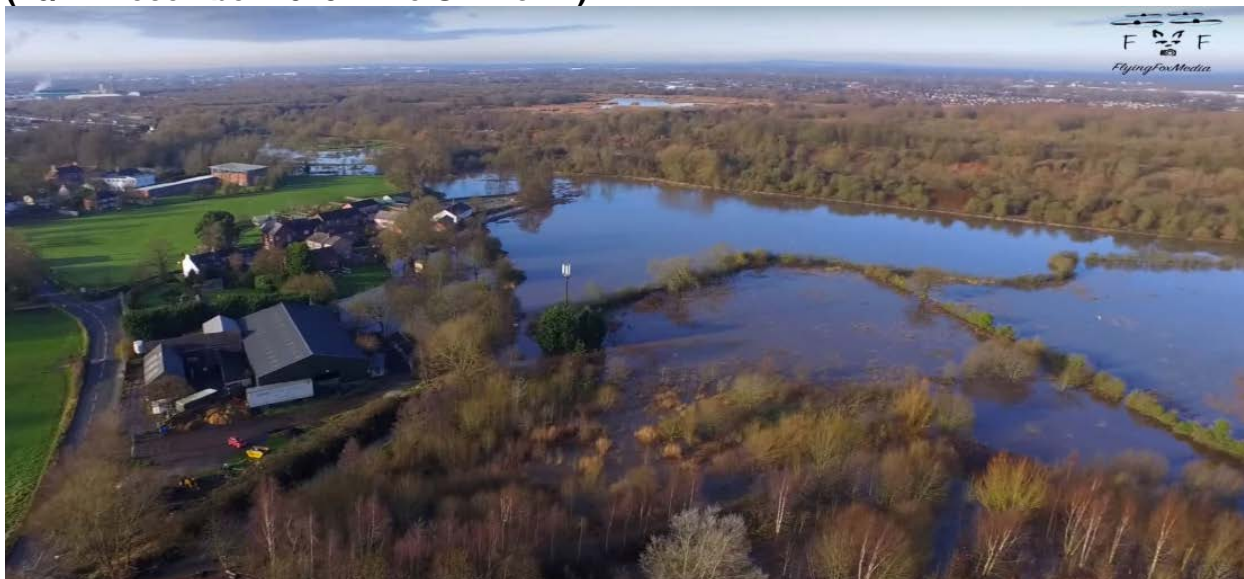
**Figure 5: Image from Flying Fox Media which shows flooding to Thelwall.
(26/27 December 2015 Time Unknown)**

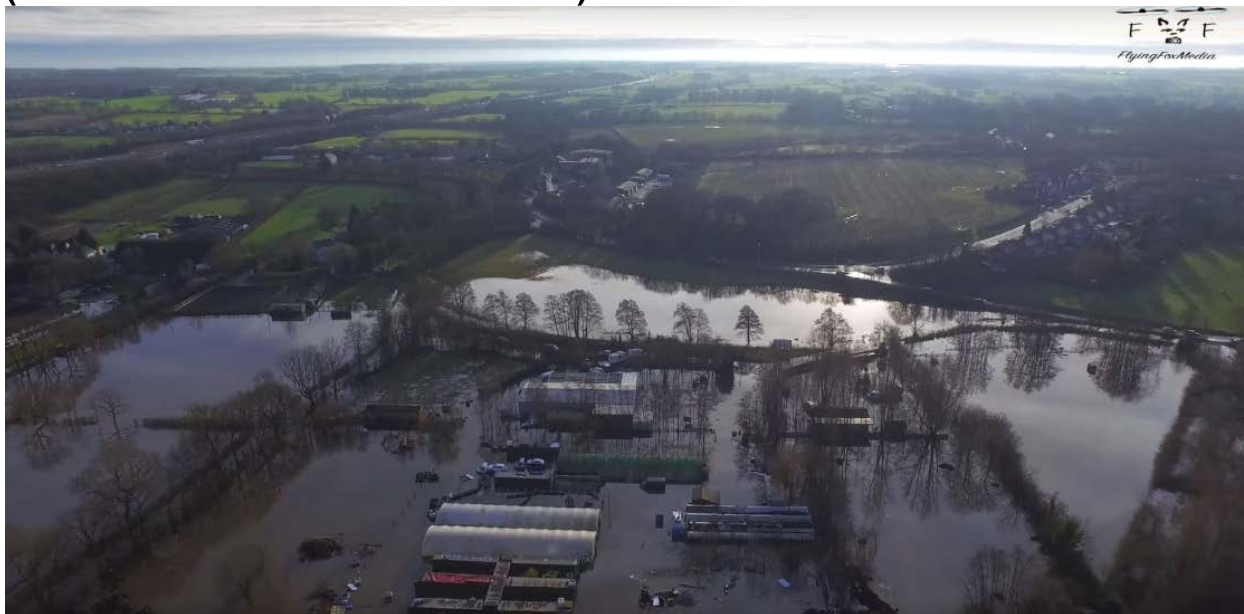
**Figure 6: Image from Flying Fox Media which shows flooding to Thelwall.
(26/27 December 2015 Time Unknown)**

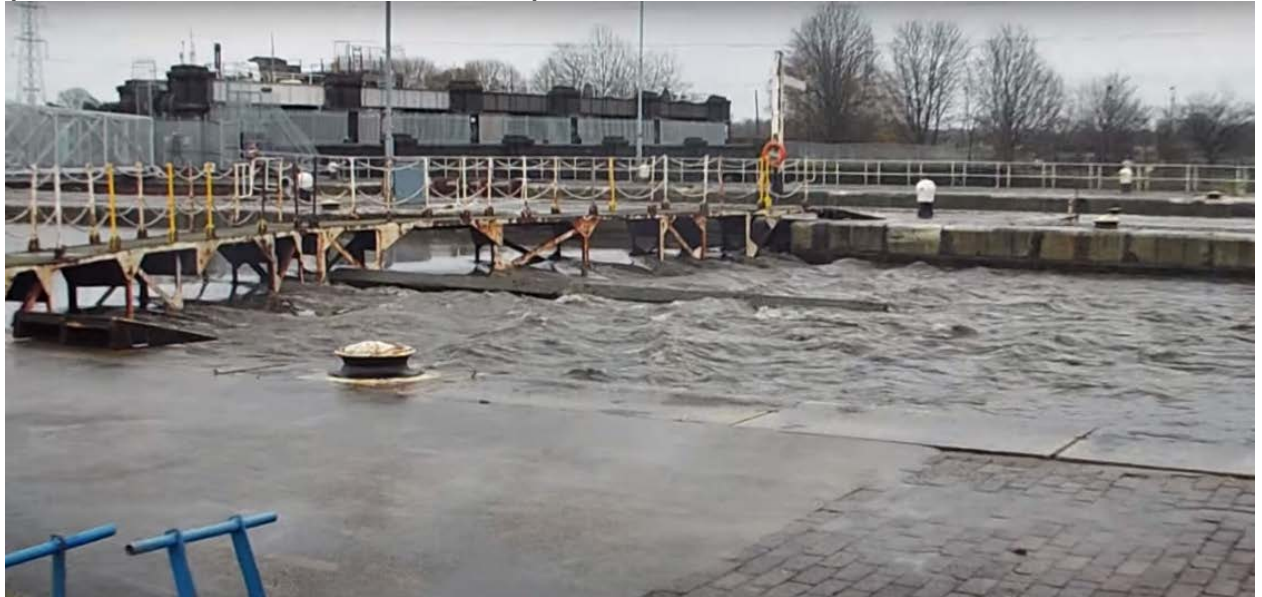
capacity at Irlam Locks on 26 December 2015 and overtopping Latchford Locks (see Figures 10, 11 and 12)

**Figure 10: Image of Manchester Ship Canal at Irlam Locks.
(26 December 2015 Time Unknown)**

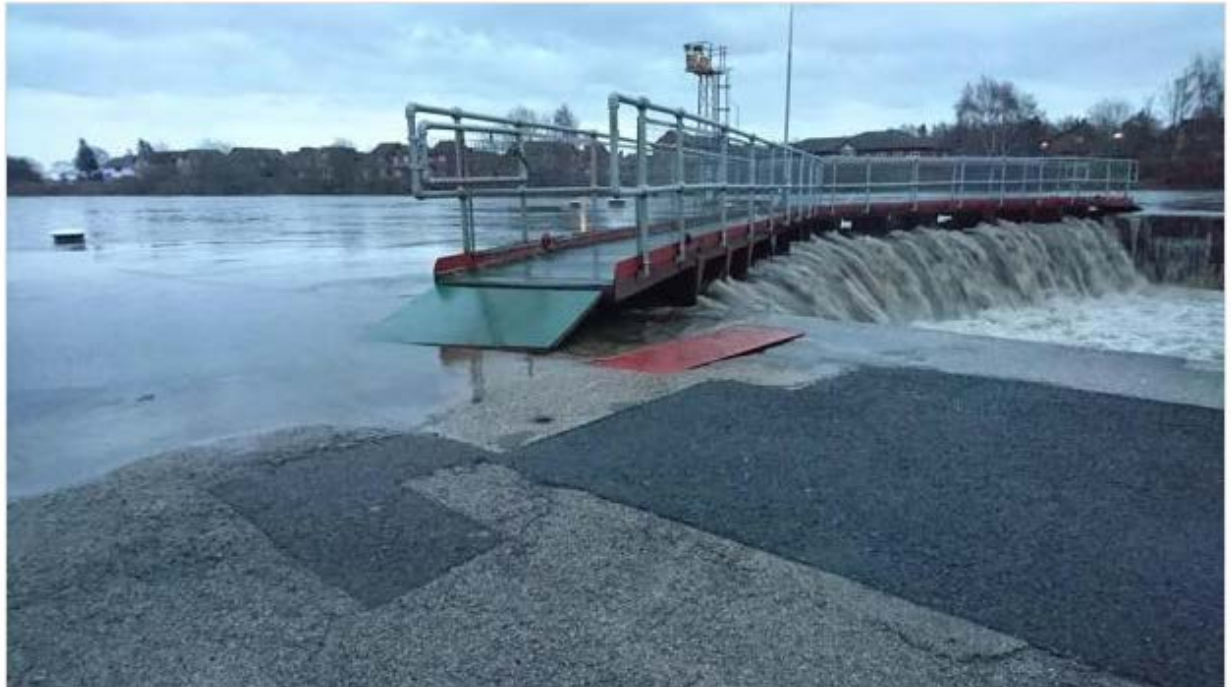
**Figure 11: Image of Manchester Ship Canal at Latchford Locks.
(26 December 2015 Time Unknown)**

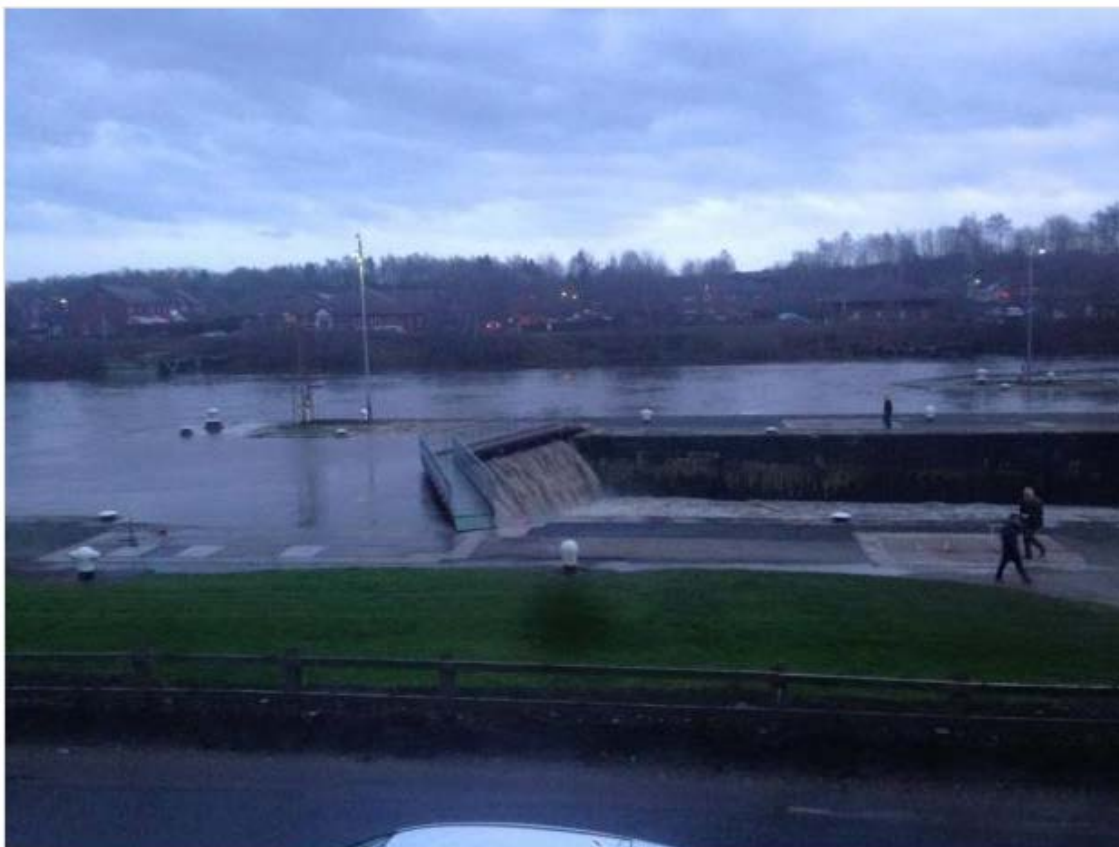
**Figure 12: Image of Manchester Ship Canal at Latchford Locks
(26 December 2015 Time Unknown)**

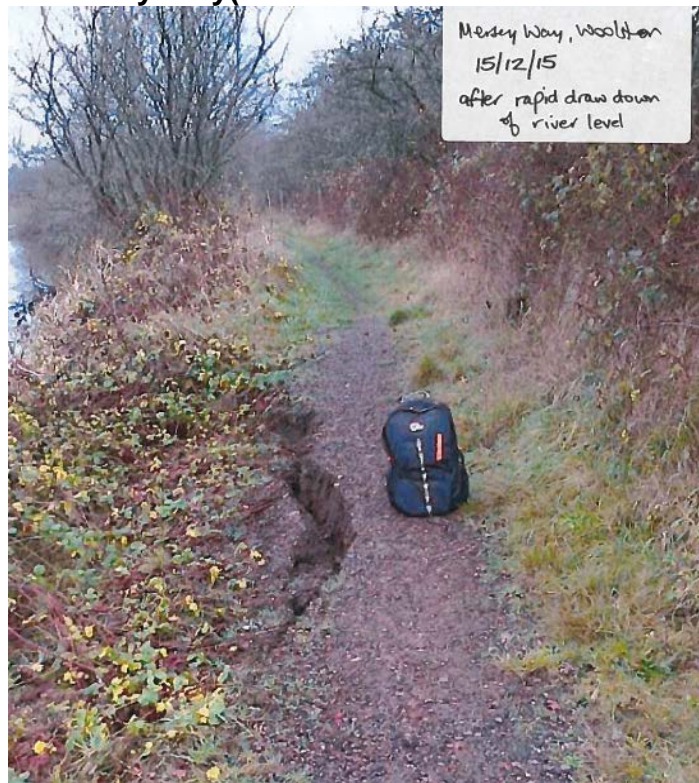
Warrington Borough Council received reports that over the weekend of 12/13 December 2015 that the water levels in the River Mersey had dropped rapidly which had caused bank collapses at Woolston (See figure 13).

Figure 13: Image of Mersey Way(15 December 2015 Time Unknown)

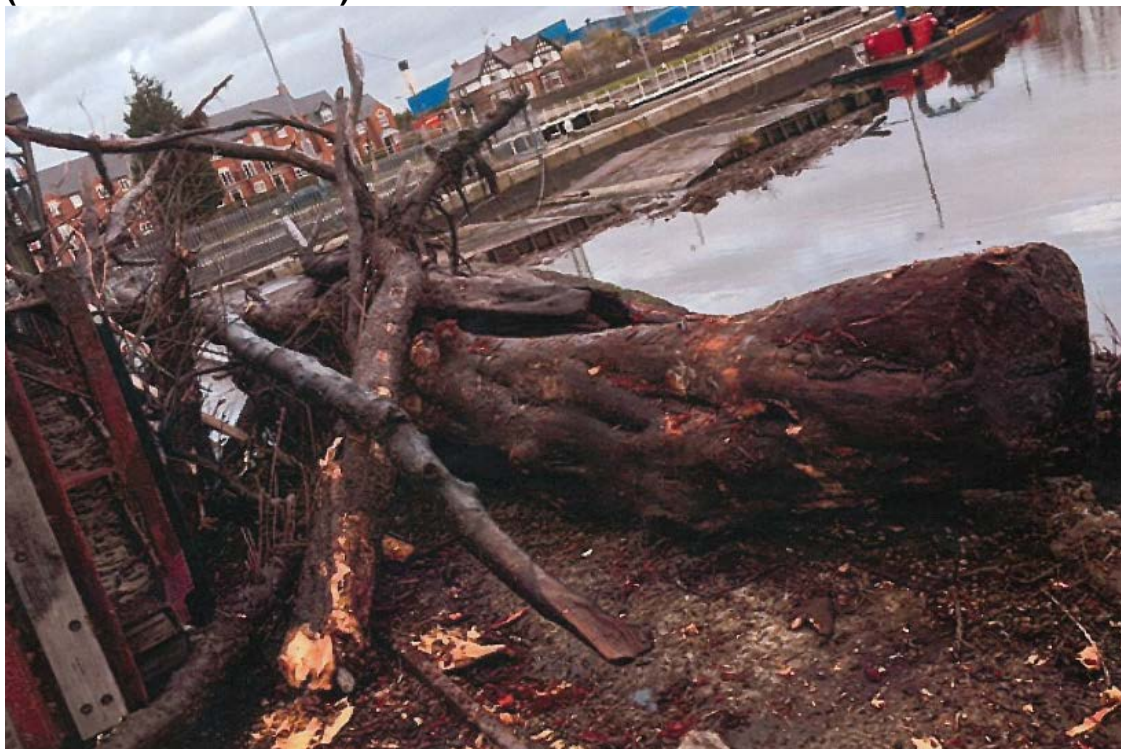
Figure 14: Image of Manchester Ship Canal at Latchford Locks (Date / Time Unknown)

At Latchford Locks, heavy rainfall in mid-December had carried a significant amount of debris into the Canal, and this debris caused damage to one of the sluice gates. Flows subsided sufficiently for the sluice to be dammed and safely assessed on 17th December, when it was discovered that the damage sustained by the sluice gate was considerable, thus rendering it inoperable.

Owing to the on-going repairs to the damaged sluice gate, sluicing capacity at Latchford was reduced by a third on Boxing Day. Furthermore, the Spring tide which also occurred on Boxing Day night reduced the outflow capacity of the River Mersey at Woolston, which meant that flows down the Canal tended naturally towards Latchford Locks. This naturally occurring combination of Spring tide, extreme rainfall and the already significant flows coming down the Canal from the Manchester area resulted in higher than normal water levels at Latchford Locks (a perfect storm scenario).”

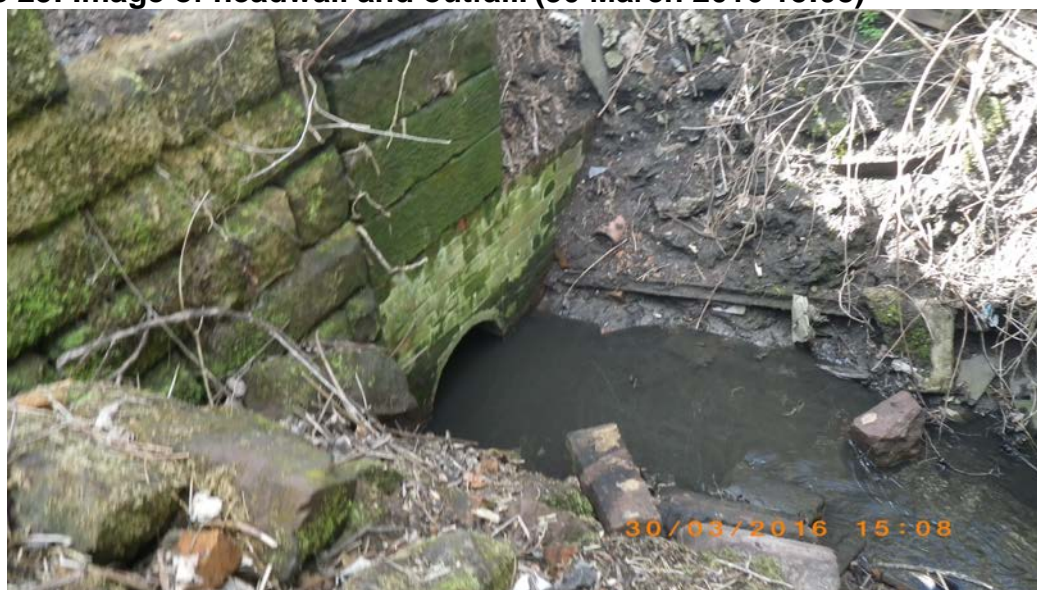
It was noted that the ordinary watercourse is in need of de-silting as the outfall pipe is approximately 30% blocked due to the siltation level. The de-silting of the watercourse is the responsibility of the riparian owner.

The headwall at the outfall is in poor condition, however during a site visit on 30 March 2016. It was observed to have partially collapsed but not blocking flow in the watercourse. The repair of this structure is the responsibility of the riparian owner.

Figure 25: Image of headwall and outfall. (30 March 2016 15:08)

- To continue to monitor condition of culvert under Ferry Lane.
- To try to identify land owner/owners of headwall at point E on drawing no: LD2016/006/002 and discuss the necessary repairs.

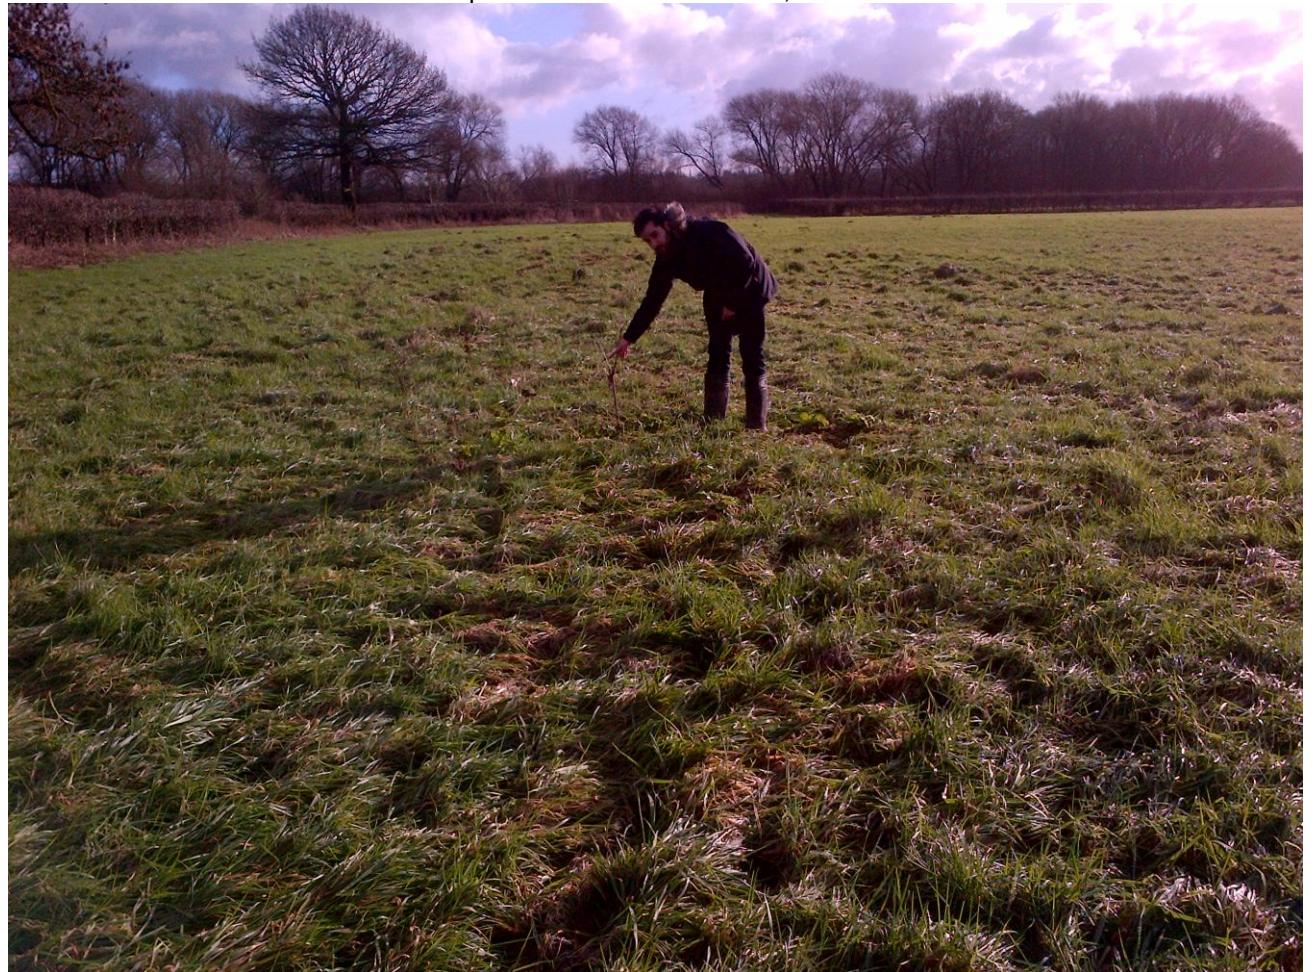
Photo 1. One of the embankment low spots. From SJ6700088350, view N. 14/01/16.

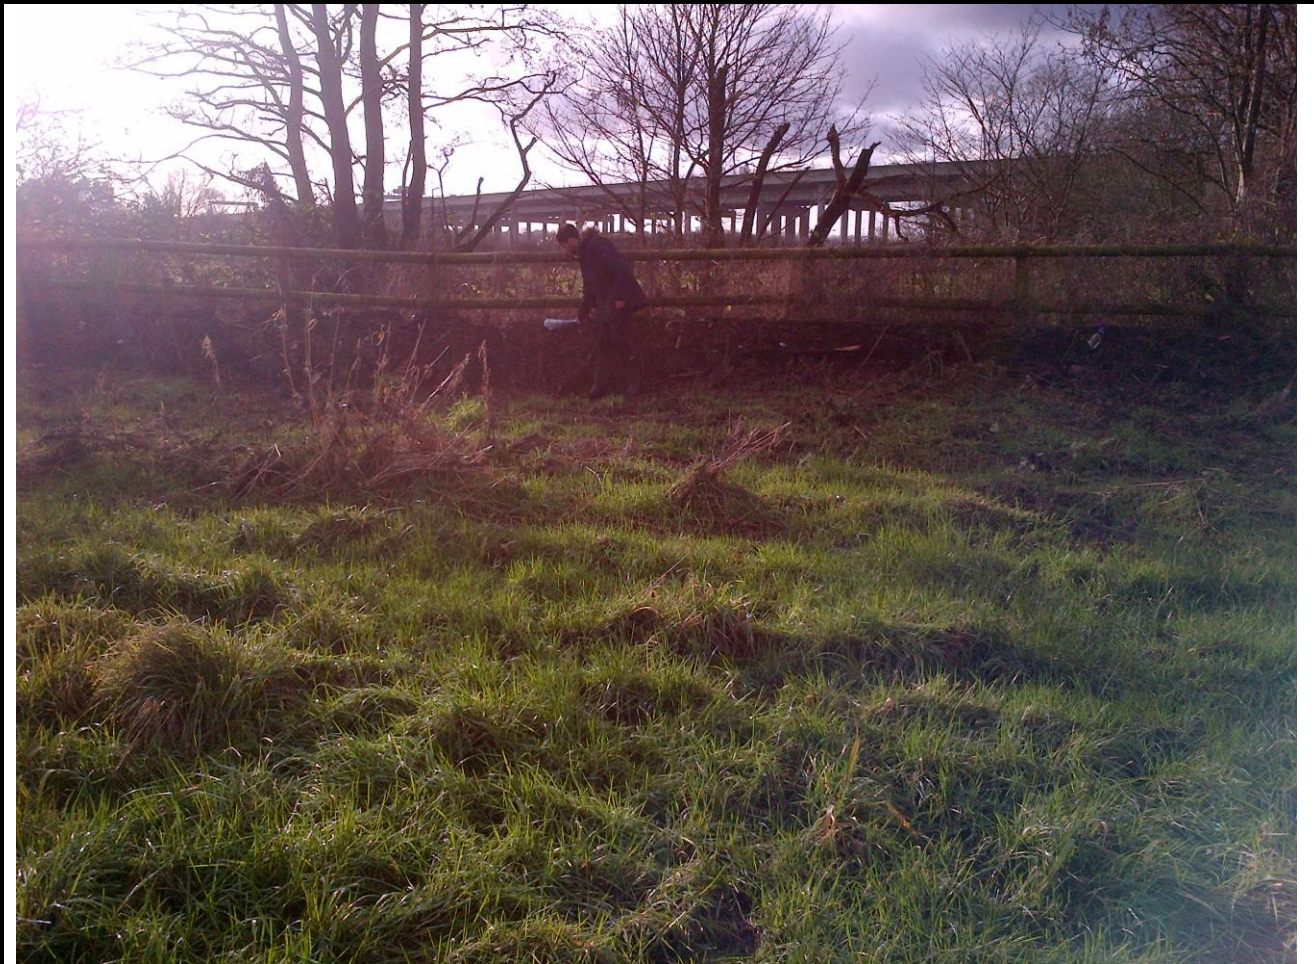
Photo 2) Back into the field – Wrack on vegetation indicates water height. From SJ6697788380, view S. 14/01/16

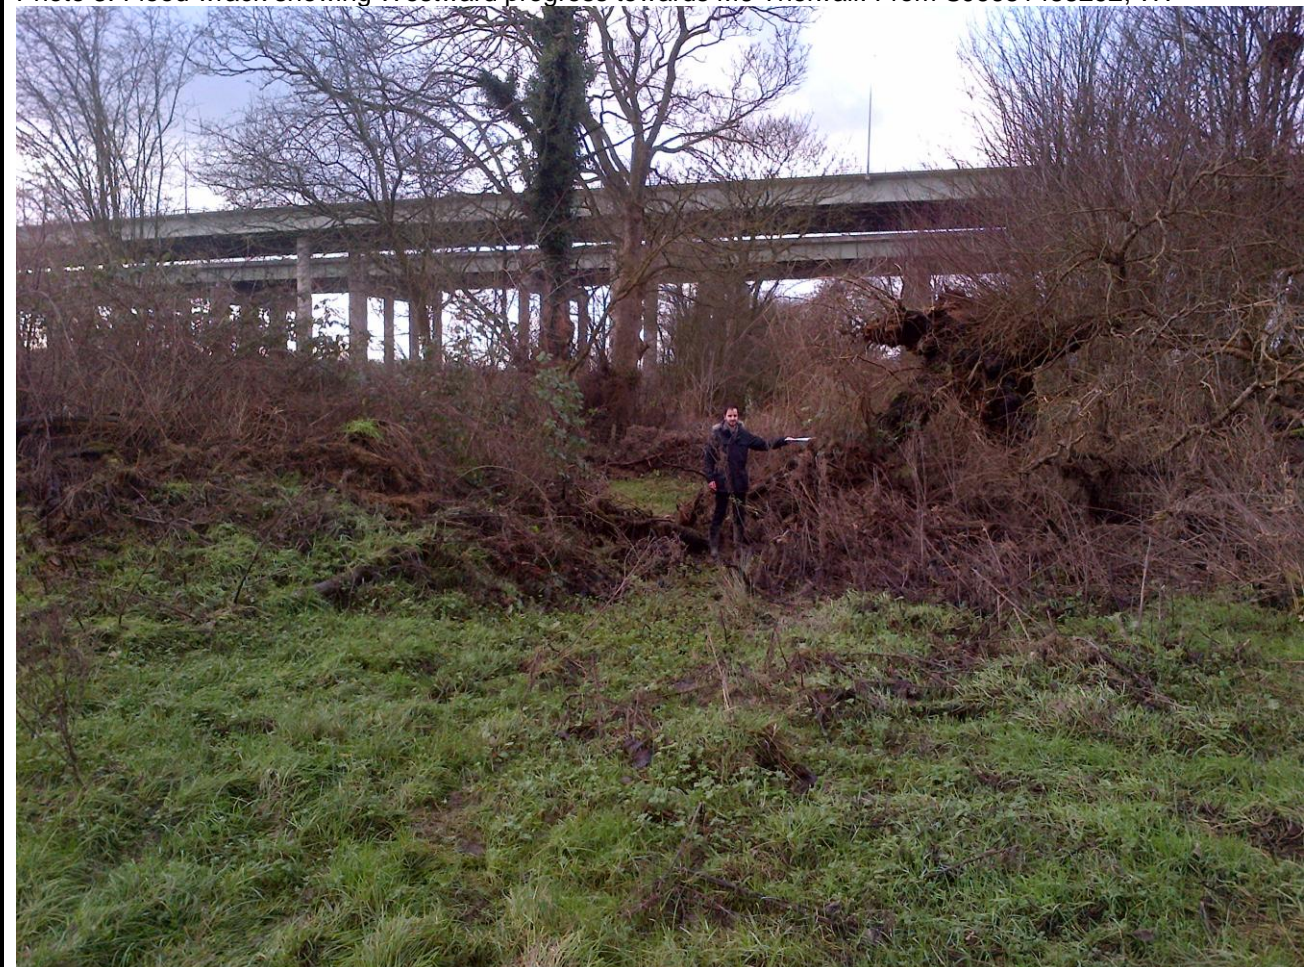
Photo 3. Flood wrack showing Westward progress towards M6 Thelwall. From SJ6681488292, W.

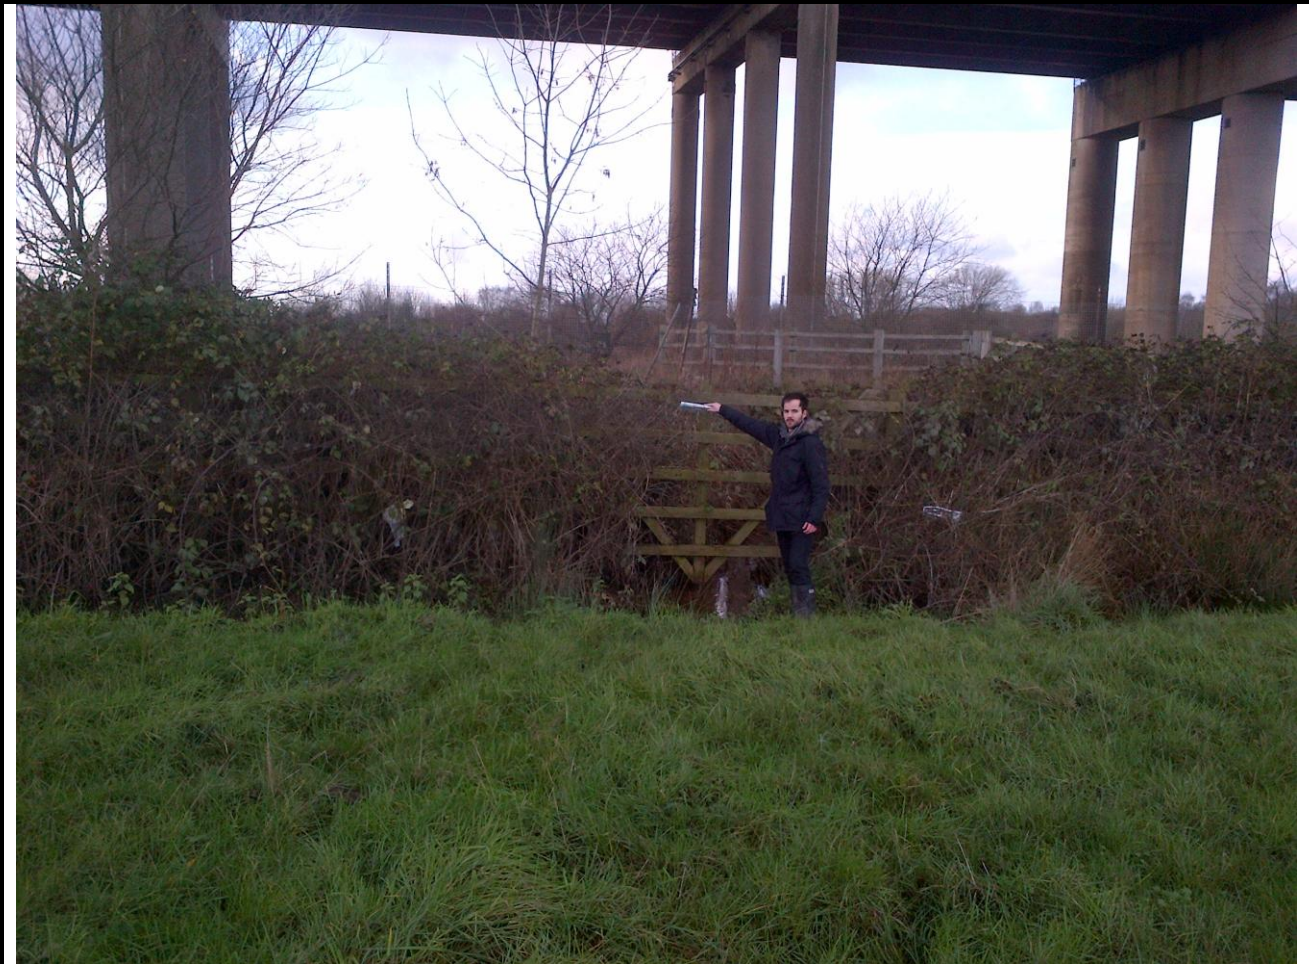
Photo 4, Next field. Flood wrack showing Westward progress towards M6 Thelwall. From SJ6667988170, W

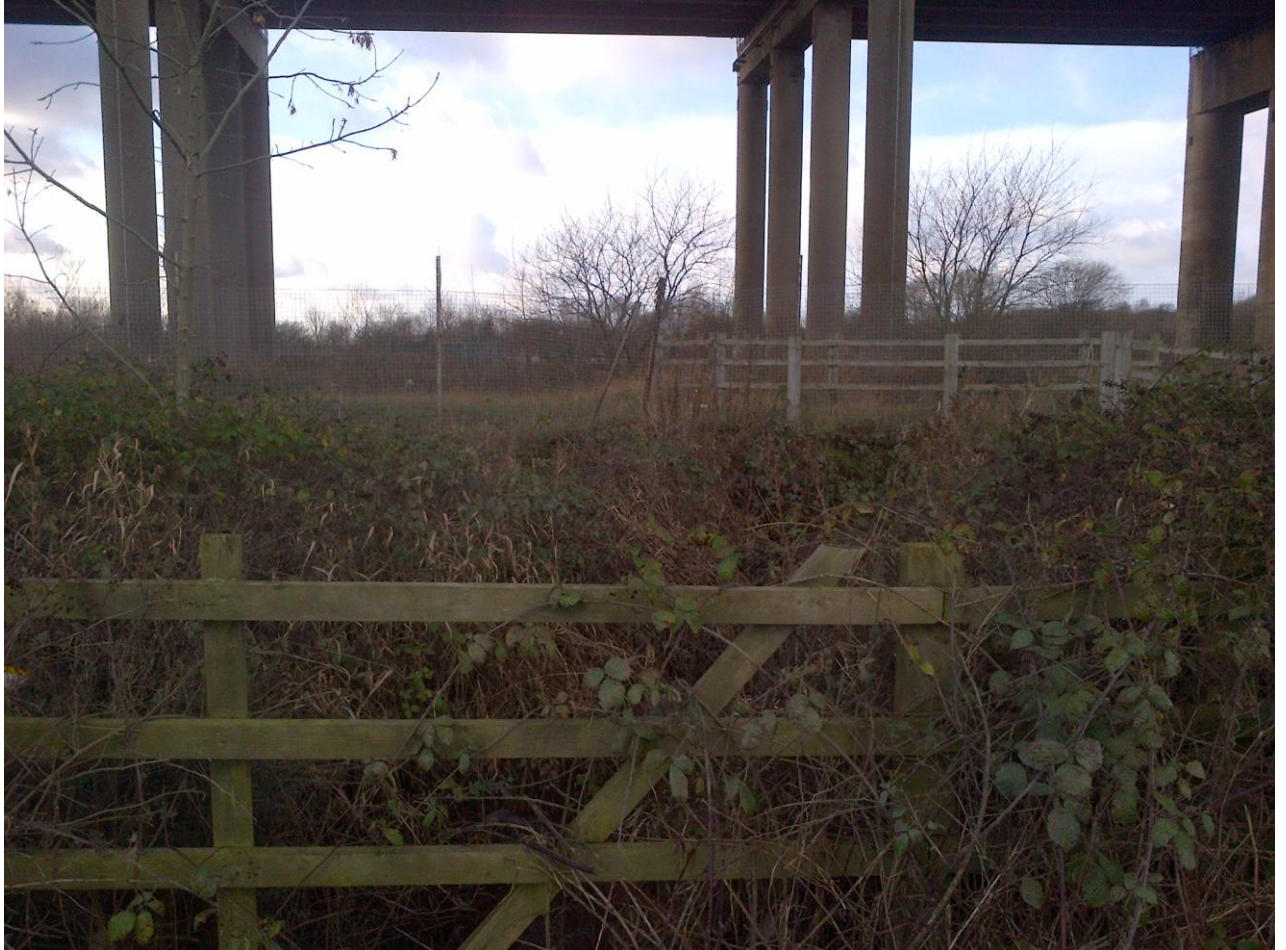
Photo 5) Thelwall boundary (drain), level indicates wrack. From SJ6655588102, W.

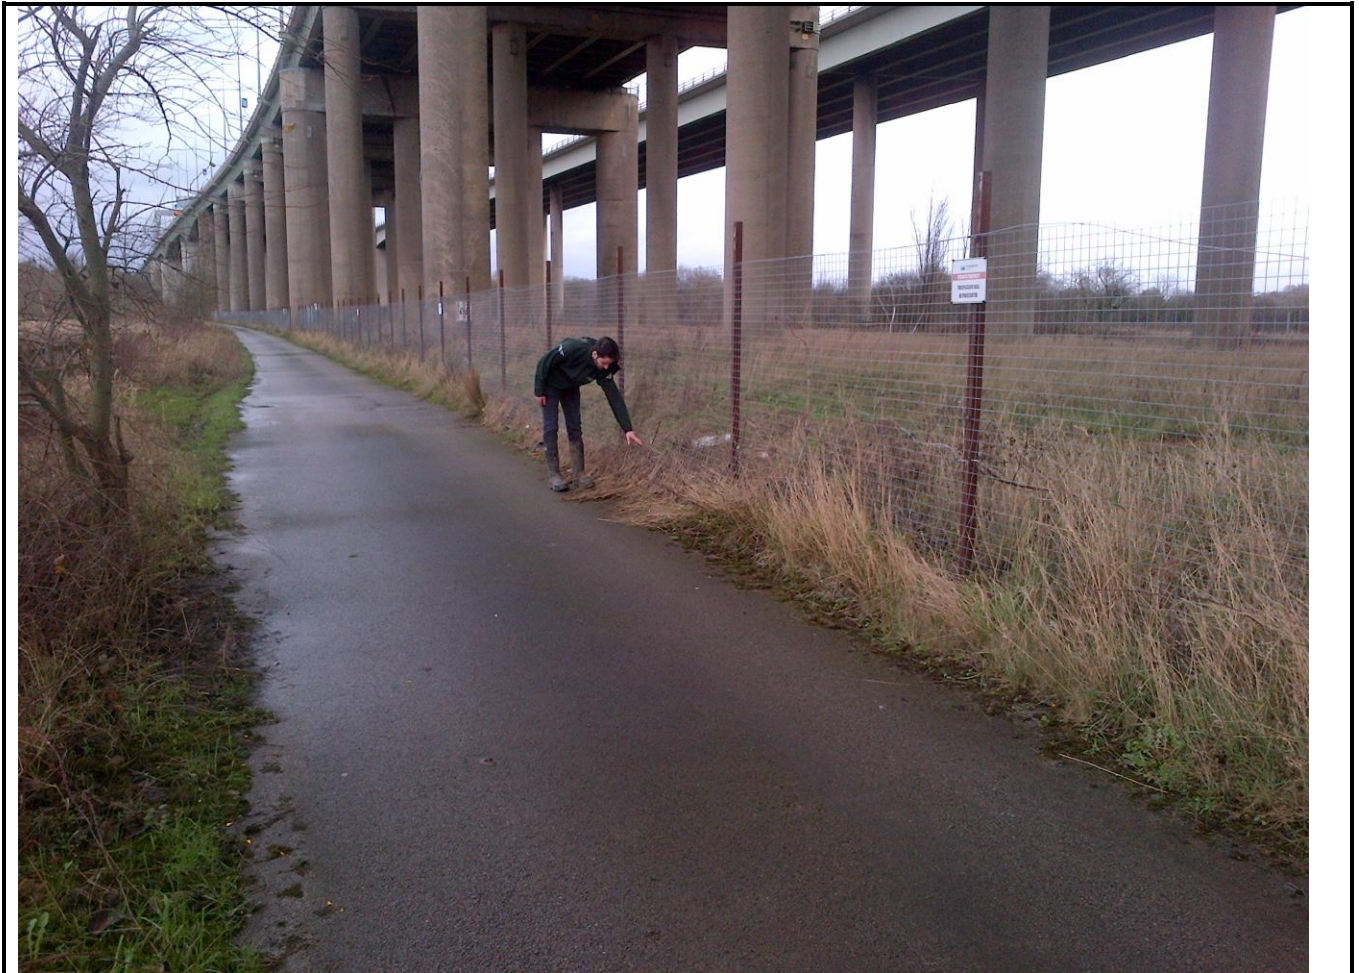
Photo 1. Flow under Motorway. From SJ6648487736, N. 27/01/16.

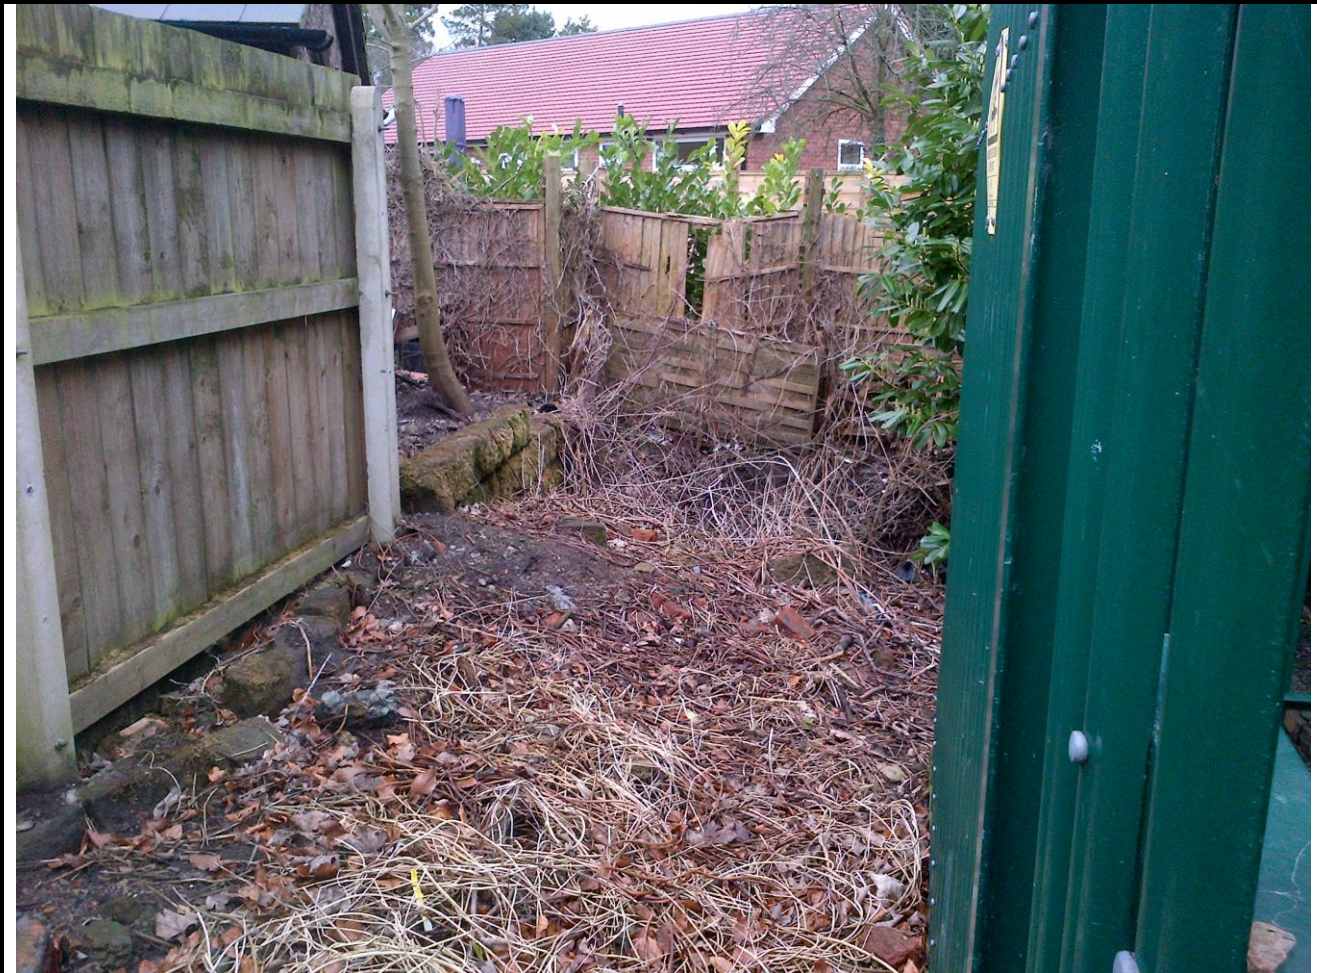
Photo 7) Back of Old Post Office, Thelwall. From SJ6521987561, N.

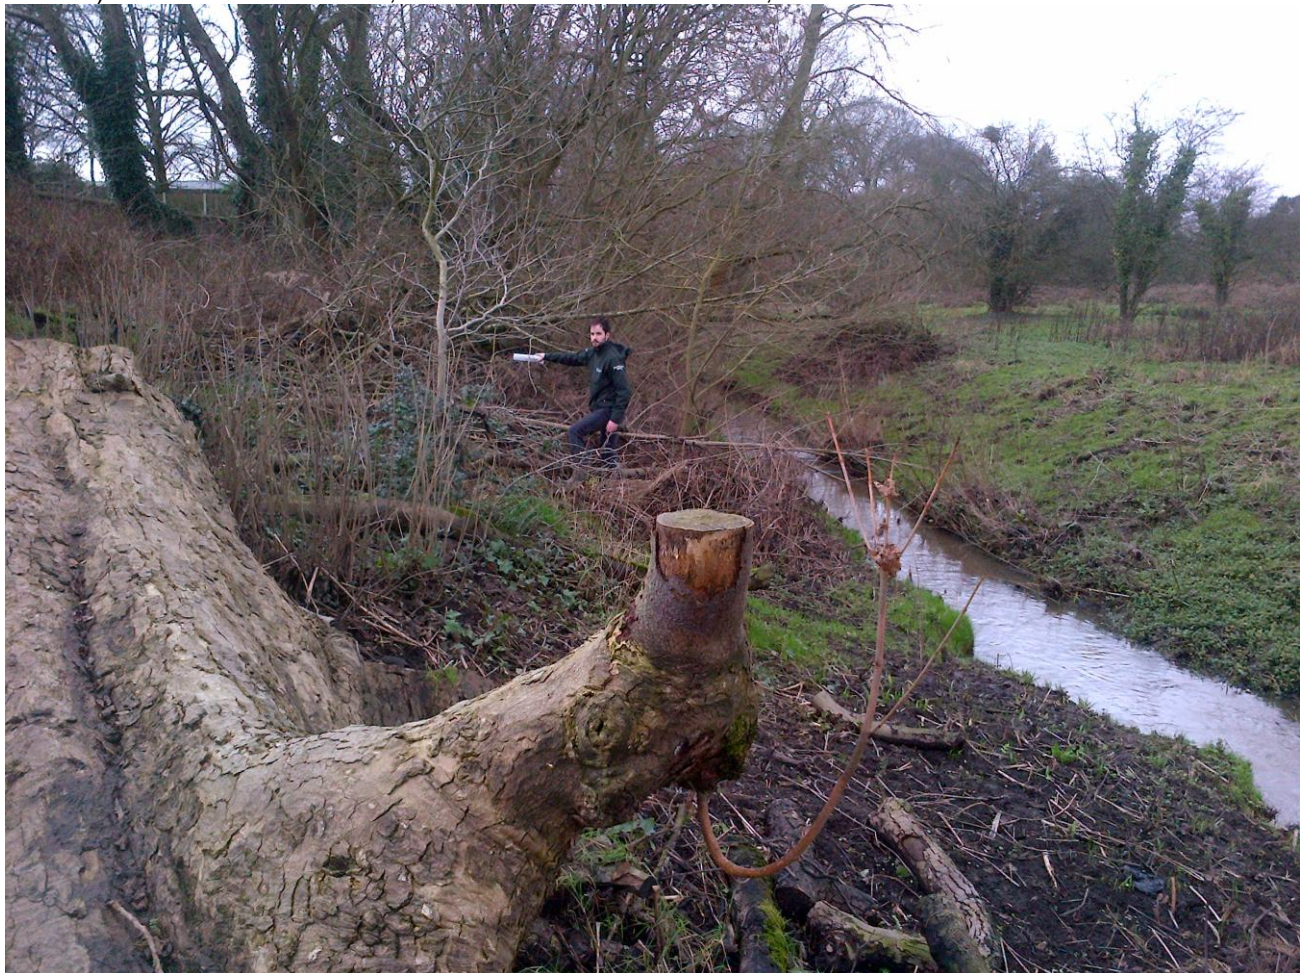
Photo 8) flood Level on Thelwall Brook. From SJ6548887724, West

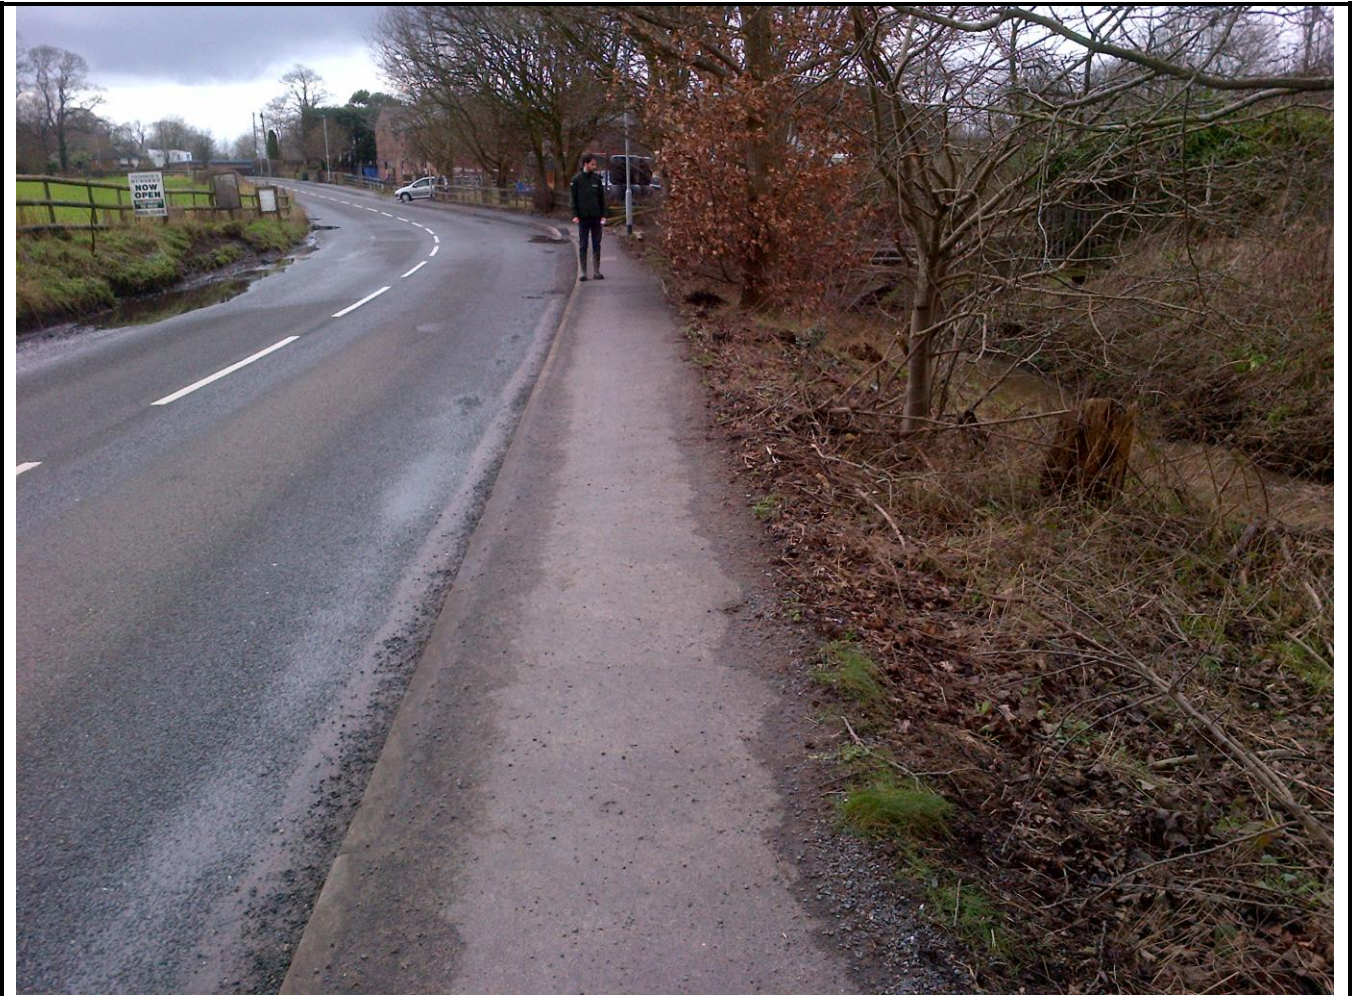
Photo 9) Thelwall Brook, adjacent to Lymm Rd., and Old Hall Farm.
