# **S19 Flood Investigation Report**

**Storm Babet**

**Location: Croft, Warrington**

**Flood Investigation Reference Number: 2023/016/001**

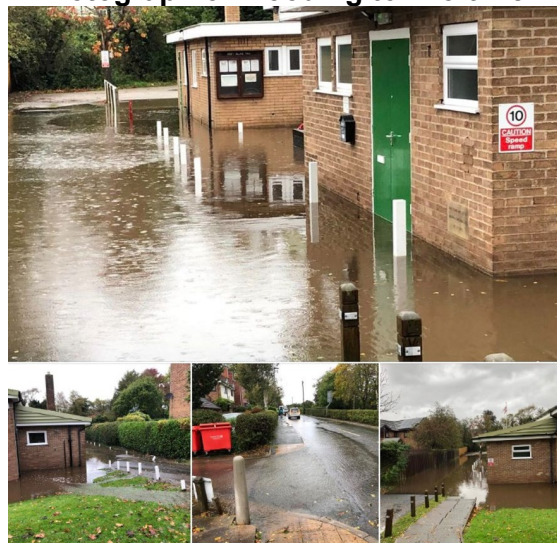
**Figure 1: Photograph of Flooding to Croft Memorial Hall**

It is understood that internal flooding occurred to 2 properties on Mustard Lane as follows:

- Croft Memorial Hall
- Croft Primary School

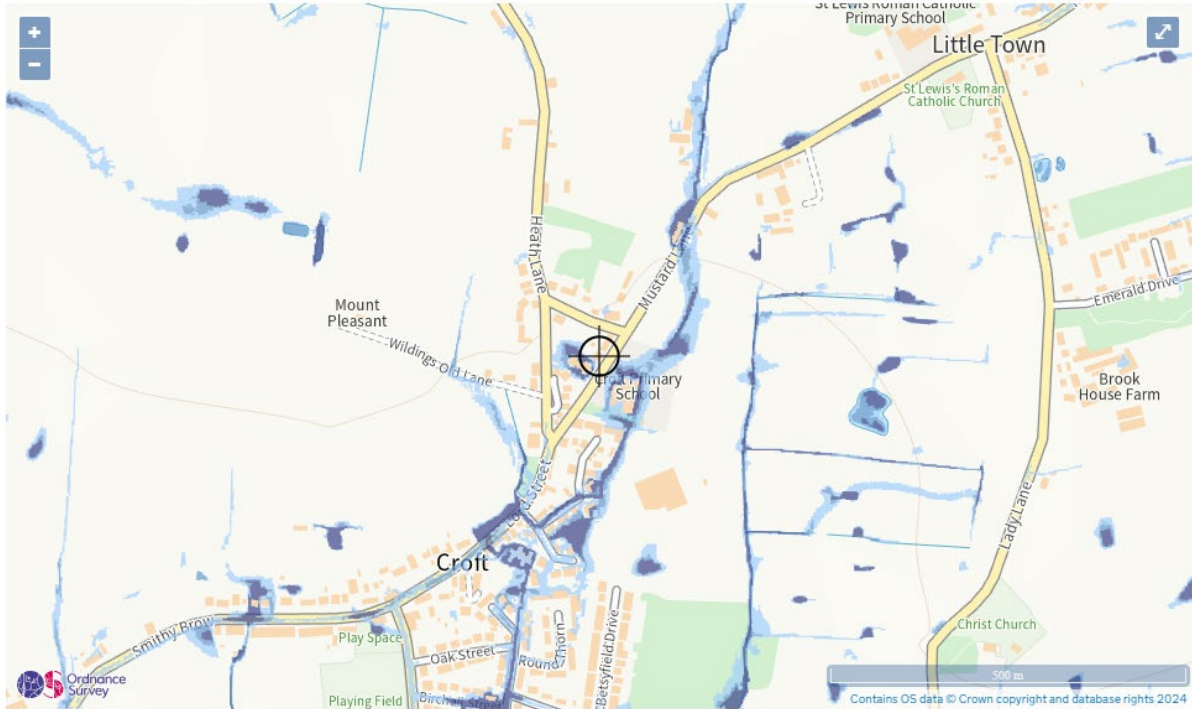
**Figure 12: Extract of Environment Agency Flooding from Surface Water Mapping**

According to the Environment Agency Risk of Flooding from Surface Water mapping, there is a significant surface water flow path running north to south through the area which appears to affect Croft Primary School. The school is shown at high risk of surface water flooding.

Croft Memorial Hall is shown as being at high risk of surface water flooding within its own independent pocket of flooding indicating a localised depression in the topography. It was verified during a site visit that Croft Memorial Hall is located in a localised depression in topography.

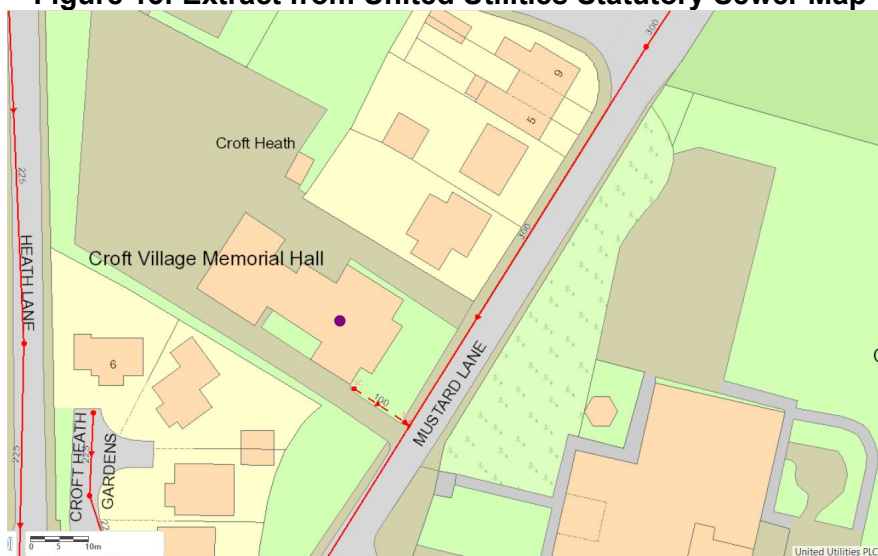
**Figure 13: Extract from United Utilities Statutory Sewer Map**

The Statutory Sewer Map was obtained from United Utilities showing the affected area of Mustard Lane. The mapping shows a 300mm diameter combined public sewer running northeast to southwest on Mustard Lane. Warrington Borough Council is not aware of foul flooding during the flood event.

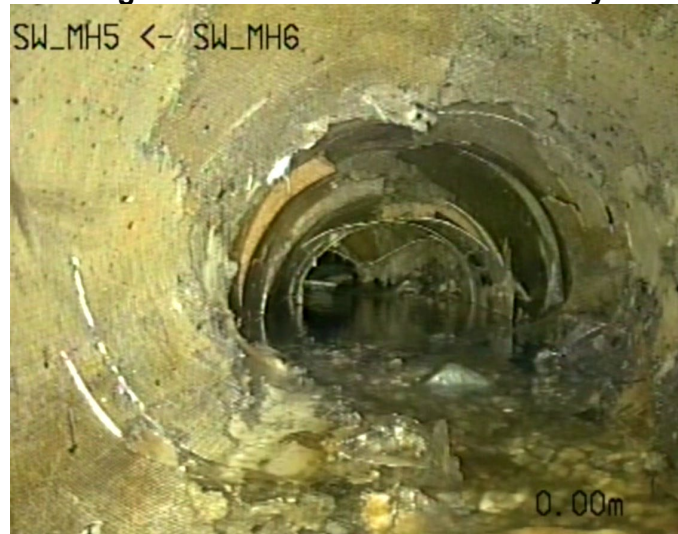
**Figure 15: Extract from CCTV Survey**

The surcharging of the drainage system indicated a blockage of the drainage system in the vicinity of Sandy Lane. This appears to have been observed by customer testimony (see section 5.1.1 above). A CCTV survey of the system was arranged which identified the following issues;

- Apparent lack of capacity of the drainage system to cope with overland flow from a very large catchment area (basic study).
- Significant tree roots in the drainage system.
- Partial failure of the liner installed circa 2016.
- Failure of the pipe adjacent to the chamber near No1 Mustard Lane creating a significant void.

During this process, it is thought that the pipe was further weakened and as a result has subsequently failed due to the increased pressure which the drainage system had been exposed to during Storm Babet.

The Contractor responsible for the installation of the liner was made aware of the defect and returned to site towards the end of 2023 and in January 2024 to remove the defective section of liner using mechanical means. Removal of the defective liner was a complicated and time-consuming operation which took an extended period of time to complete due to high flows in the drainage system.

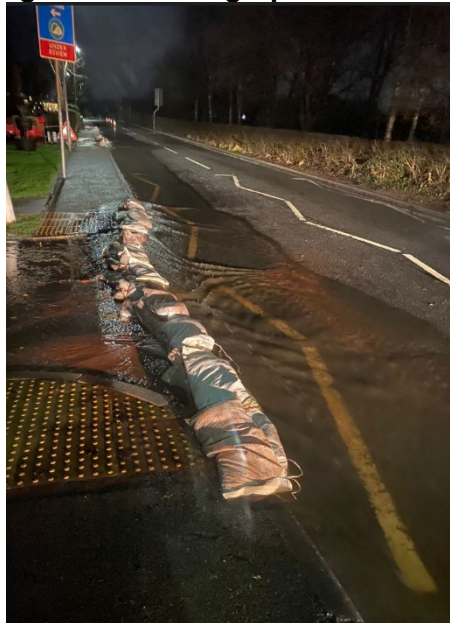
**Figure 16: Photograph of Flooding**

The common theme throughout discussion with customers was that water was surcharging from a chamber on Sandy Lane and flowing down the road and accumulating in the low area around Croft Memorial Hall.

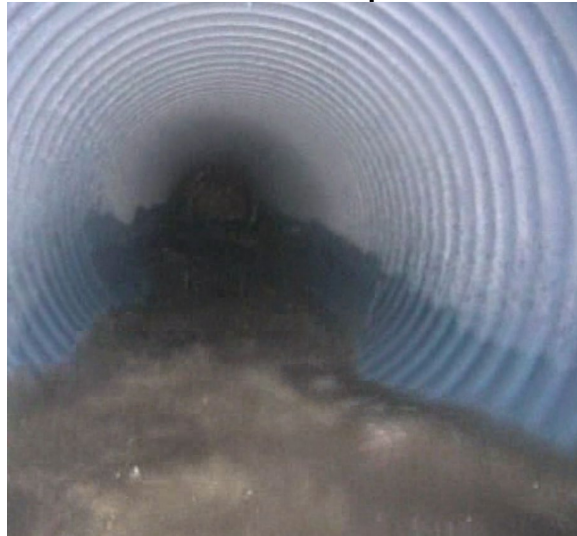
**Figure 17: Extract from CCTV Survey Upon Completion of Works Showing Repairs Section of Pipe**

Following removal of the defective liner, a further CCTV and cleaning operation was undertaken to understand the condition of the drainage system. This confirmed the extent and exact location of the failed section of drainage system as 1.0m from the chamber outside 1 Mustard Lane for a distance of approx. 10.0m upstream.

Due to severity of the failure, open cut methodology was the only option to initiate repair. Open cut repair was completed in January 2024.

The final stage in the drainage system repairs is to undertake a continuous liner to the full length of the drainage system from the chamber in Sandy Lane to the chamber in the footway adjacent to N°1 Mustard Lane (approx. 50.0m).
