**Phase 1 GeoEnvironmental
Assessment**

Land to the North of Chester Road

Walton

September 2017

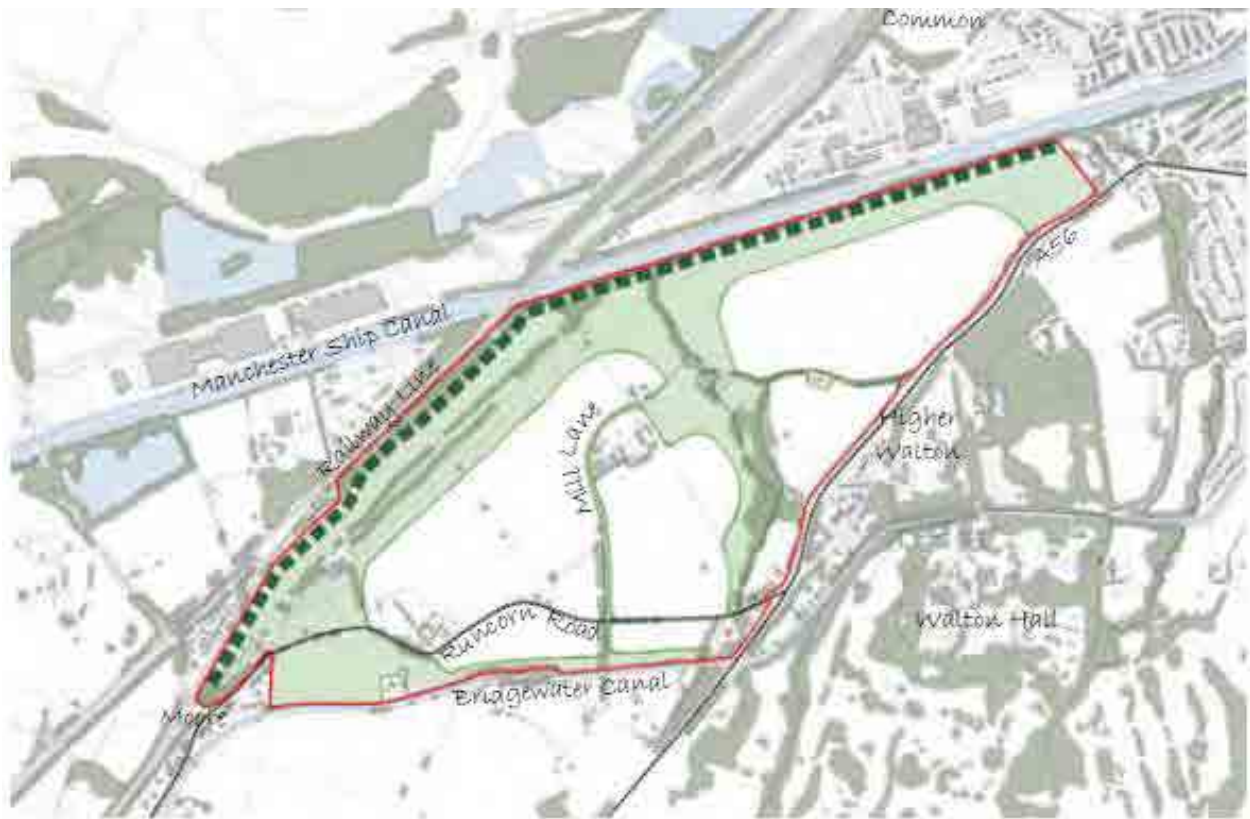
Figure 1: Peel Holdings (2016) Site Prospectus (Page 12). Ashall Homes' site is shown within the area of proposed Green Space, with indicative development parcels in white.

The Site Prospectus then goes on to outline a conceptual masterplan (Figure 2 below). Despite indicating potential development parcels in Figure 1, the proposed masterplan illustrates that a large proportion of this could be delivered as a Country Park. Peel has not consulted with Ashall Homes' on this proposed masterplan. Ashall Homes' therefore considers this concept to be an inefficient use of Green Belt land and would like to reiterate to the Council that there are no constraints (save for those previously mentioned above) which would restrict the developable area of this site. It is considered that a significant proportion of

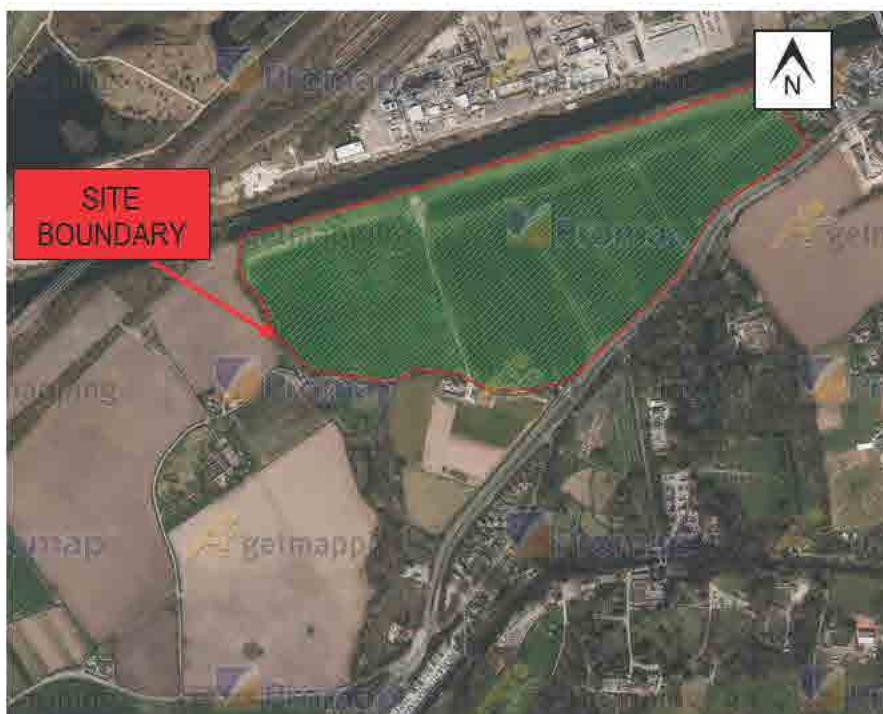
Figure 1 Site Location Plan

2.6 A location plan is shown as Figure 1, below.

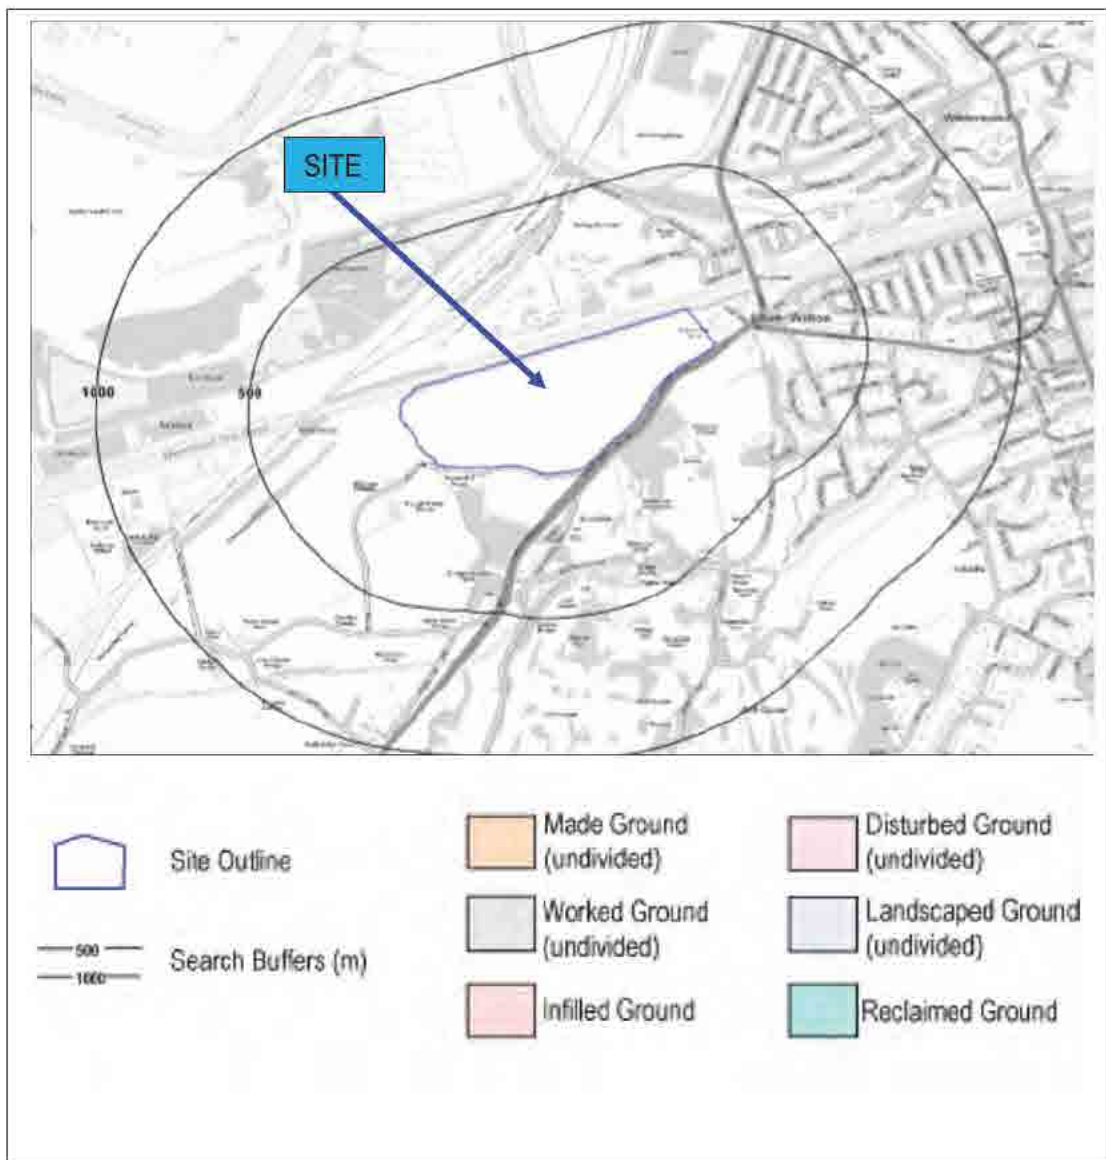
Figure 2 Artificial Ground Map

- 3.3 The BGS states that the site is not underlain by any made ground. There are no records of artificial ground located within 500m of the site. A copy of the artificial ground map is included below as Figure 2.

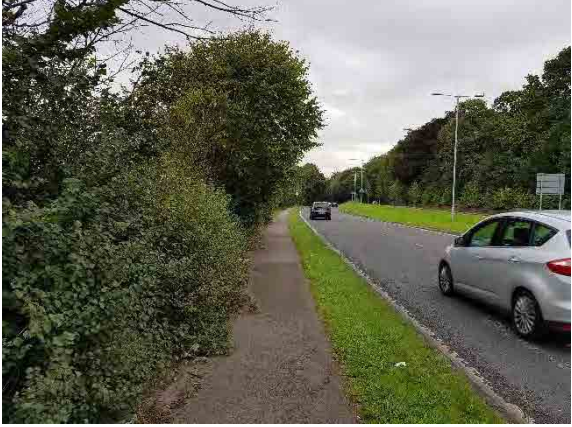
<p>Job No.: A2220/17</p>	<p>Site: Land to the North of Chester Road, Walton</p>
<p>Plate 1 Looking east along the southern site boundary.</p>	<p>Plate 2 Looking north along Mill Lane to the west.</p>

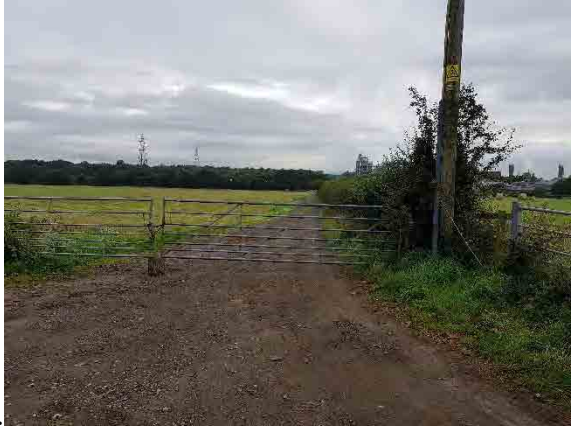
<p>Date: 31st August 2017</p>	<p>Date: 31st August 2017</p>
<p>Plate 3 Access gate off Mill Lane, southwest of the site boundary.</p>	<p>Plate 4 Gravel path in the west of the site, looking north.</p>
<p>7.</p>

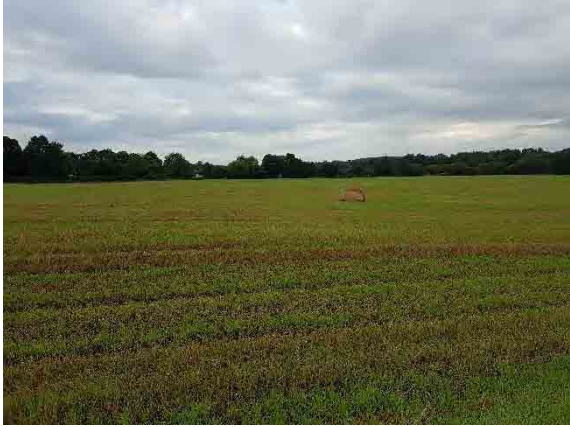
<p>Job No.: A2220/17</p>	<p>Site: Land to the North of Chester Road, Walton</p>
<p>Plate 5 Crop fields in the west of the site.</p>	<p>Plate 6 Stockpiled timber and muckheaps in the north of the site.</p>

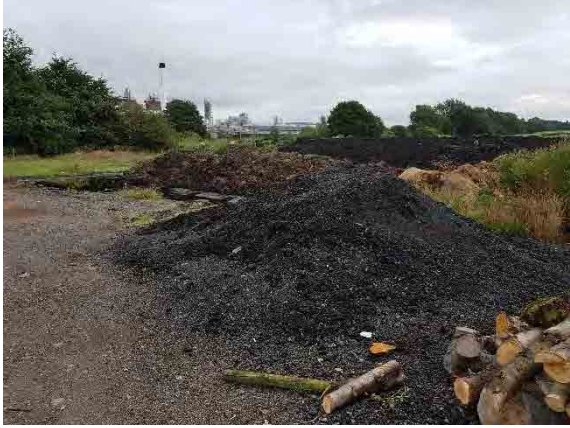
<p>Date: 31st August 2017</p>	<p>Date: 31st August 2017</p>
<p>Plate 7 Stockpiled solidified tarmacadam in the north of the site.</p>	<p>Plate 8 Pallets of timber and trailer in the north of the site.</p>

- 7.6 As part of the geotechnical investigation, it is recommended that samples of soil and groundwater are recovered for analysis for contamination and to confirm whether there are any residual risks, particularly within the former sand pit in the eastern sector of the site.

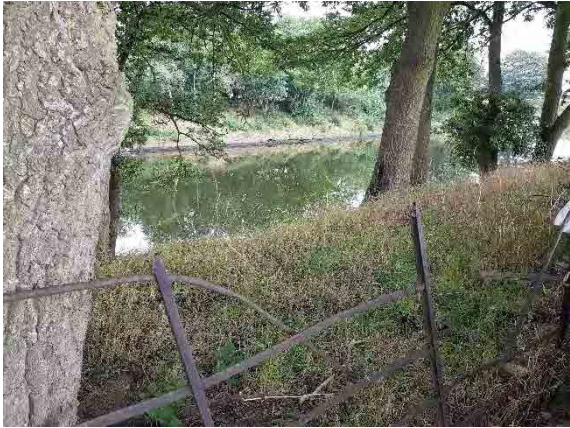
<p>Job No.: A2220/17</p>	<p>Site: Land to the North of Chester Road, Walton</p>
<p>Plate 9 Manchester Ship Canal along the northern site boundary.</p>	<p>Plate 10 Looking west along the northern site boundary</p>

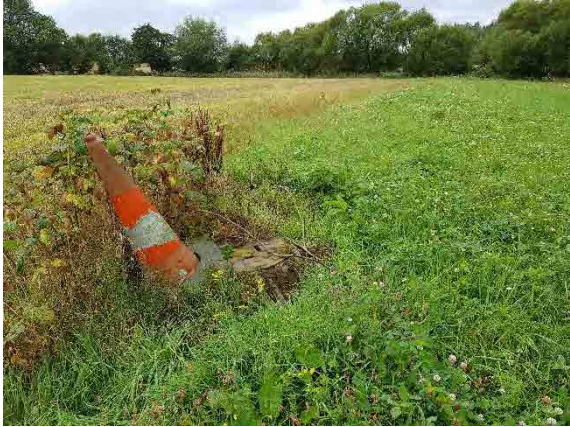
- 5.6 Large areas of Himalayan Balsam were also observed along the western and northwestern site boundaries.
- 5.7 Evidence of underground services were observed in the north of the site, running east to west.

<p>Date: 31st August 2017</p>	<p>Date: 31st August 2017</p>
<p>Plate 11 Services in the north of the site.</p>	<p>Plate 12 Himalayan Balsam in the west of the site, along the watercourse.</p>

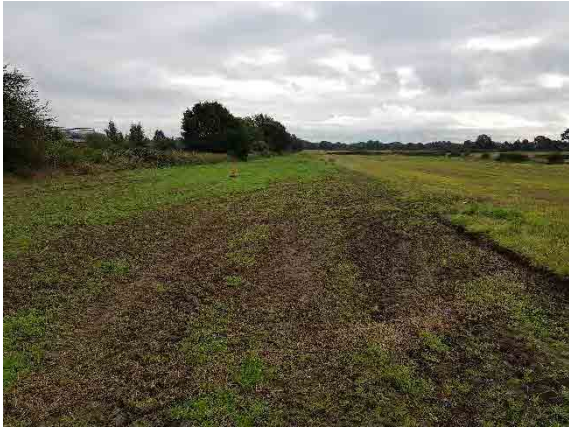
<p>Job No.: A2220/17</p>	<p>Site: Land to the North of Chester Road, Walton</p>
<p>Plate 13 Northern site boundary looking east.</p>	<p>Plate 14 North of the site looking southeast.</p>

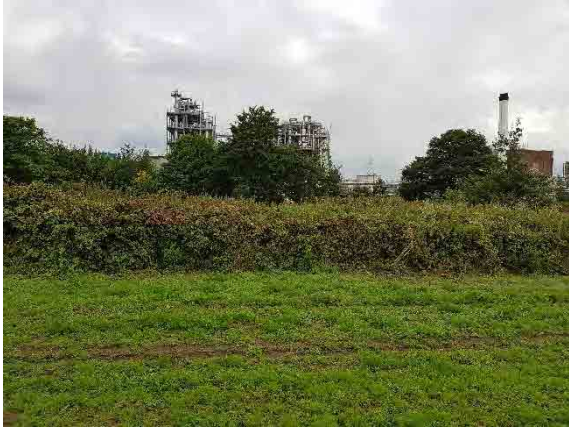
<p>Date: 31st August 2017</p>	<p>Date: 31st August 2017</p>
<p>Plate 15 Solvay Interlox beyond the northern site boundary.</p>	<p>Plate 16 Eastern site boundary and adjacent residential dwelling.</p>

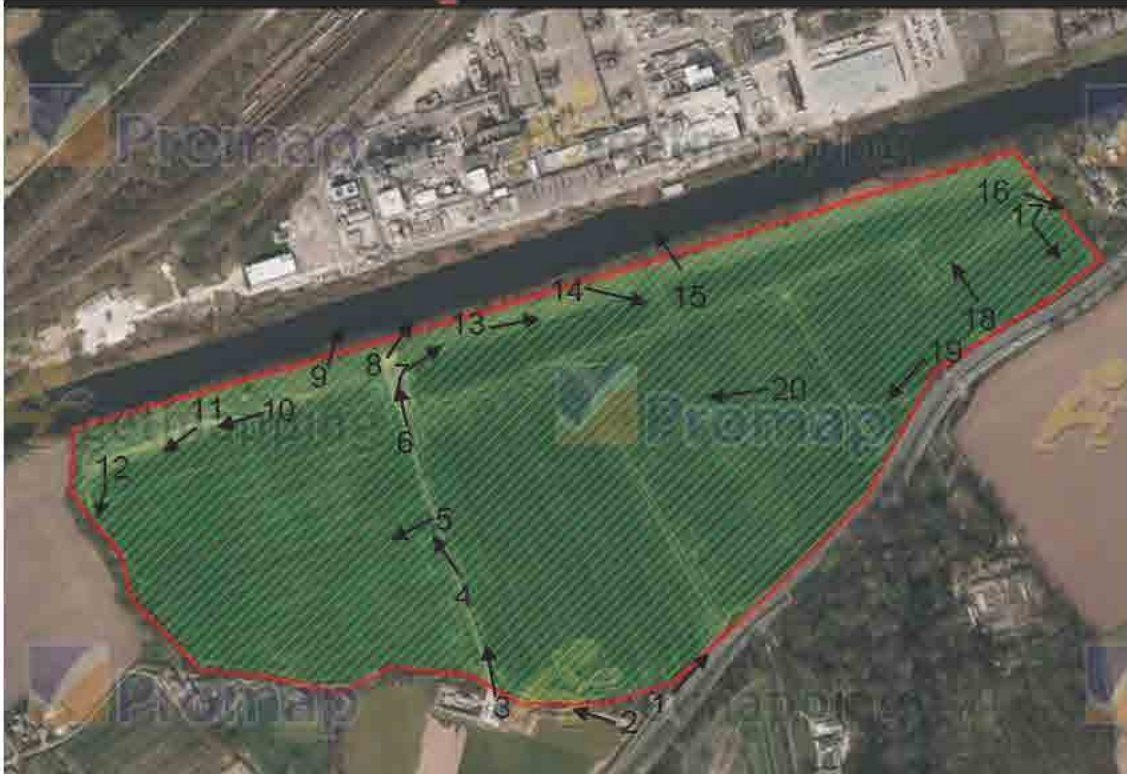
Figure 10 Site Walkover Photo Locations

- 5.1 A walkover survey was completed on the 31st August 2017. The photographs and notes from this survey are appended to this report as Appendix 2 and Appendix 3 respectively.
