S19. (1) Flood Investigation Report

Warrington Borough Council – Lead Local Flood Authority

Location: Thelwall / Lymm

Flood Investigation Reference Number: 2016/006/001

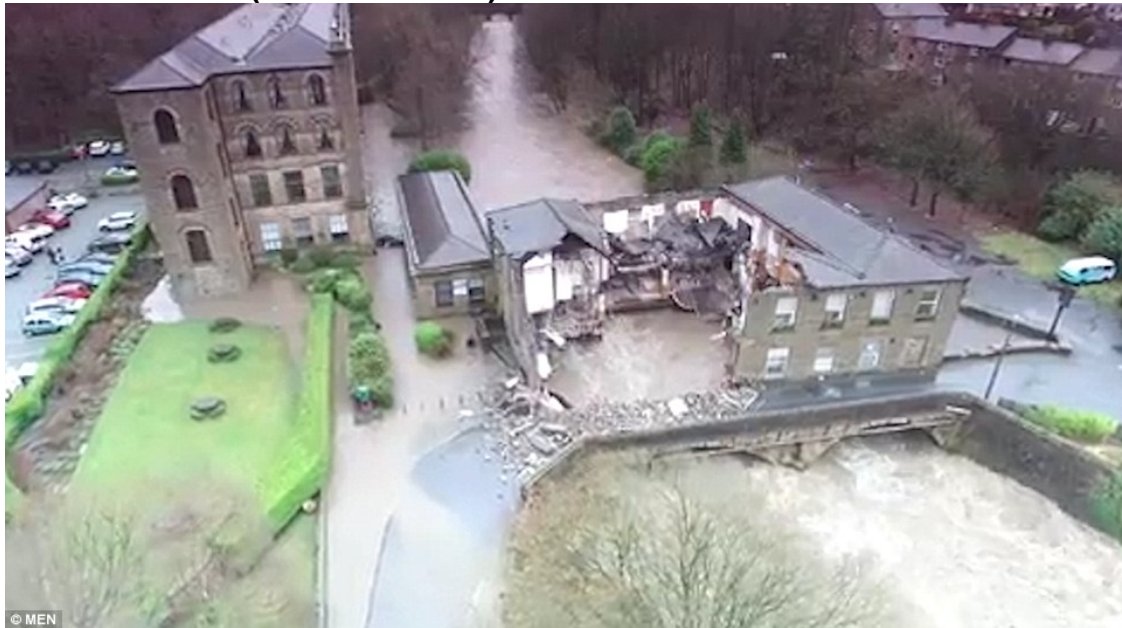
Figure 7: Image of the Waterside pub in Summerseat which collapsed on 26 December 2015 (Time Unknown) into the River Irwell.

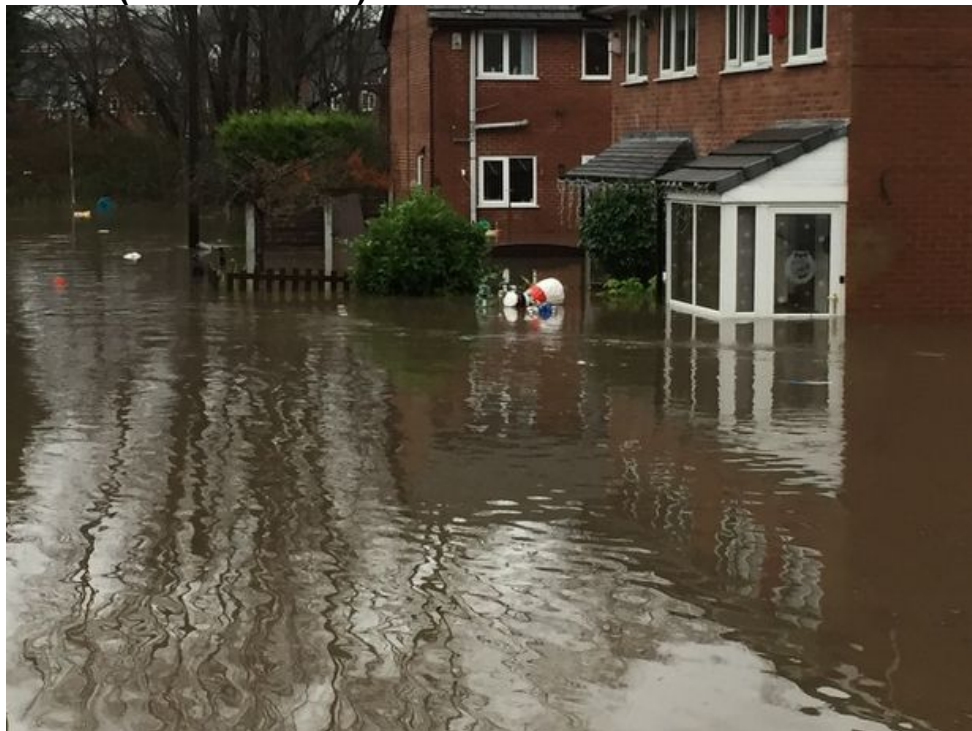
Figure 8: Image of the Riverside Drive in Radcliffe which flooded on 26 December 2015 (Time Unknown) when the River Irwell breached its banks.

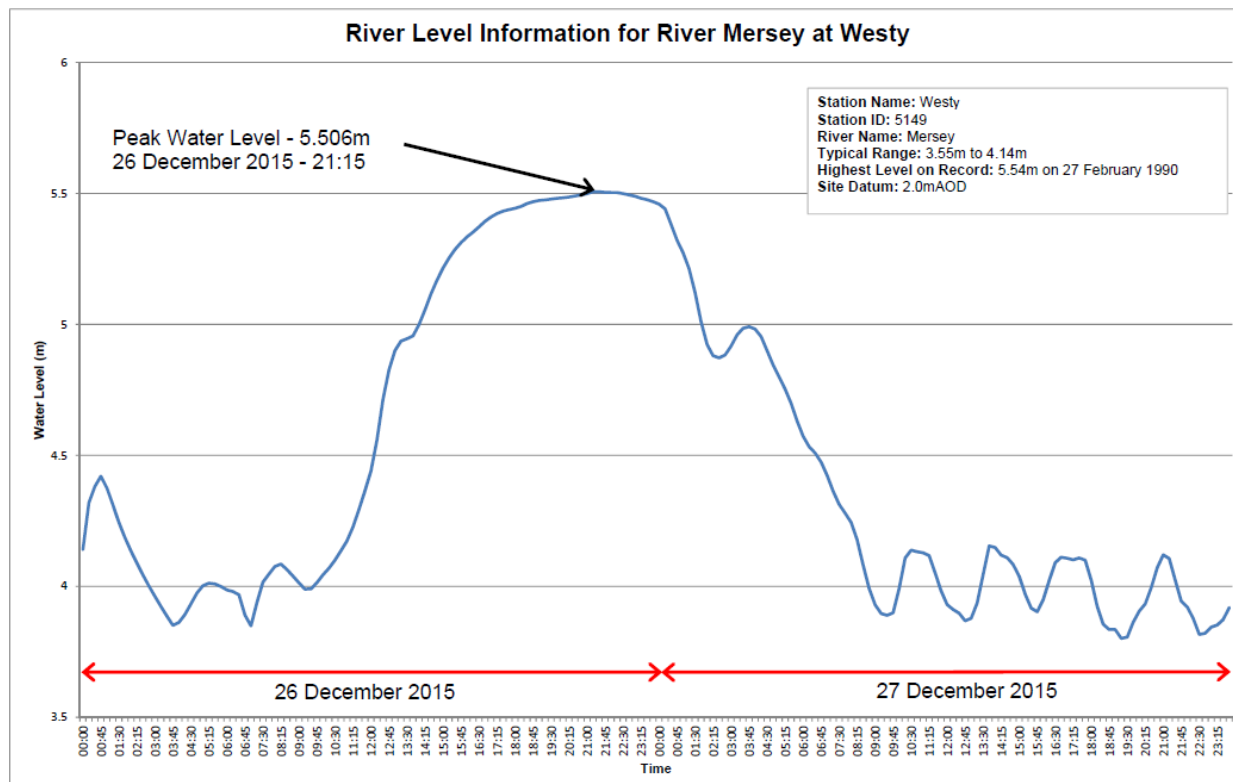
Figure 9: River Level Information for the River Mersey at Westy.

A peak water level of 5.506m was observed during the flood event at 21:15 on 26 December 2015.

The highest previously recorded level was 5.540m (34mm higher than event observed on 26 December 2015).

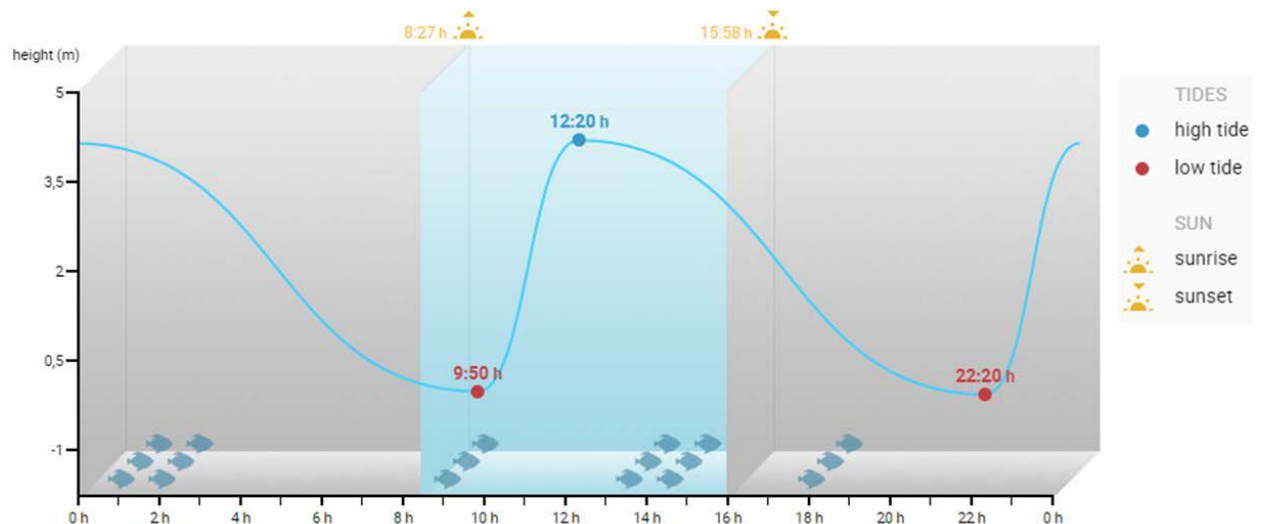
Figure 15: Tide information for Mersey Estuary at Runcorn/Widnes

On 26 December 2015 for the River Mersey at Runcorn/Widnes, the first low tide was at 09:50 and the next low tide was at 22:20. The only high tide of the day was at 12:20, another high tide was experienced at 00:40 on 27 December 2015.

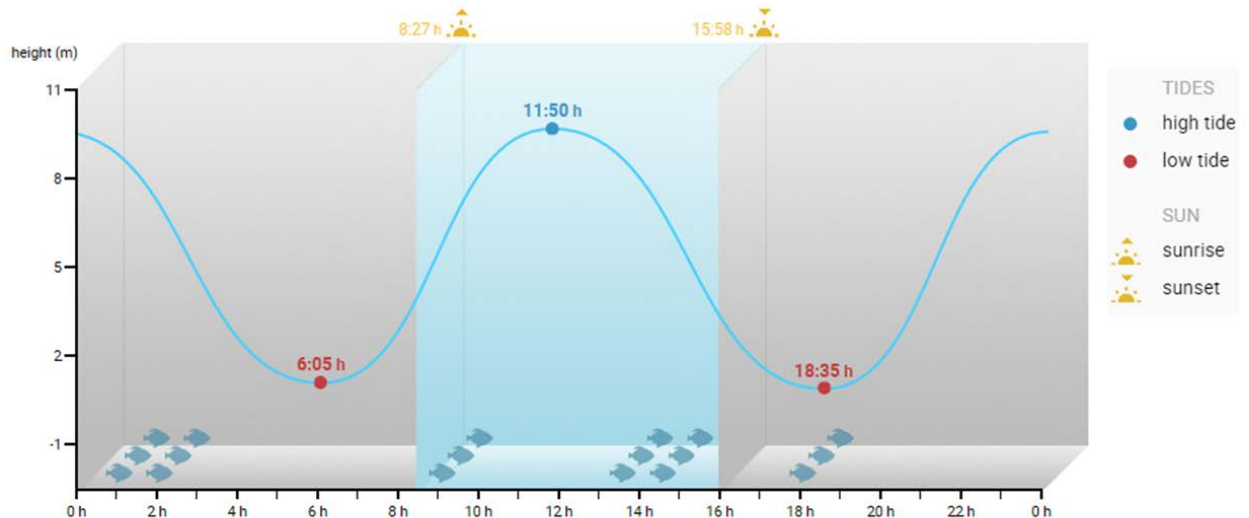
The entrance locks at Eastham on the Wirral side of the Mersey seals off the Canal from the tidal estuary.

Figure 16: Tide information for Mersey Estuary at Runcorn/Widnes

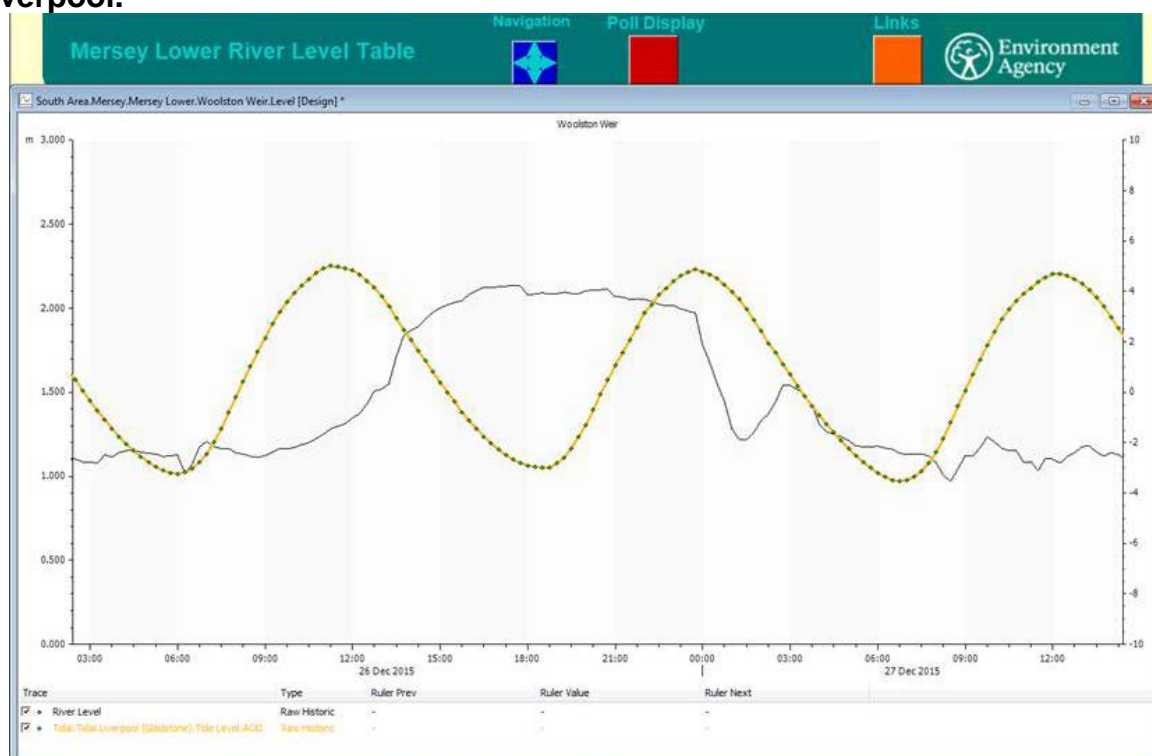
In the absence of water level recordings for the Manchester Ship Canal, the full impacts of the tide on the operational level of the canal cannot be quantified, however, they are likely to be considerably less significant than other effects.”

Figure 17: Graph showing tidal peaks for the Mersey at Woolston Weir and Liverpool.

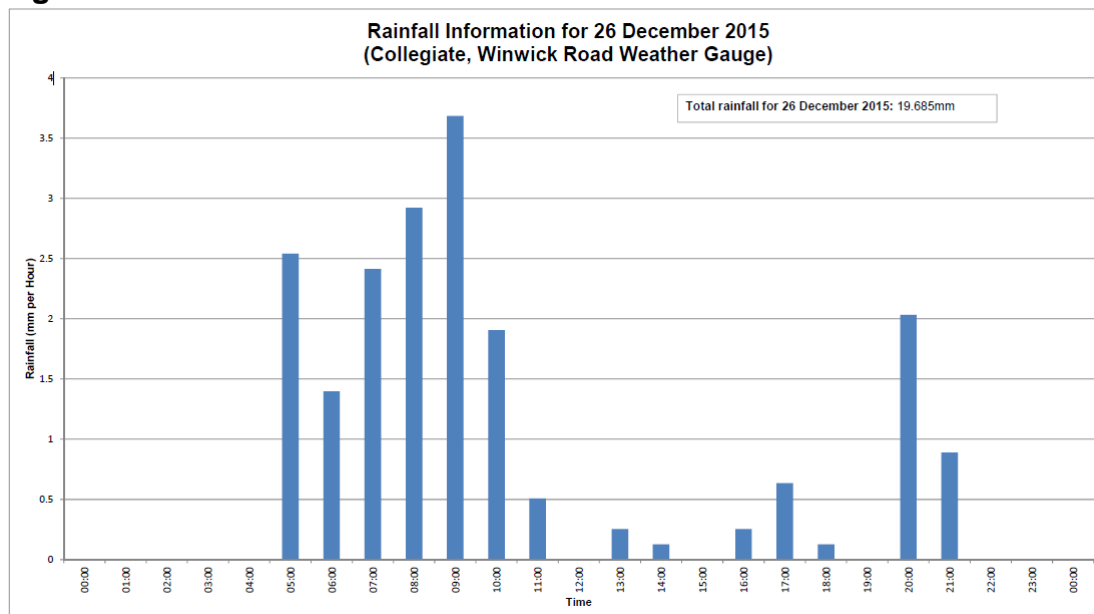
- 25 December 2015: 9.271mm
- 26 December 2015: 19.685mm
- 27 December 2015: 0.00mm

Figure 18: Rainfall information.

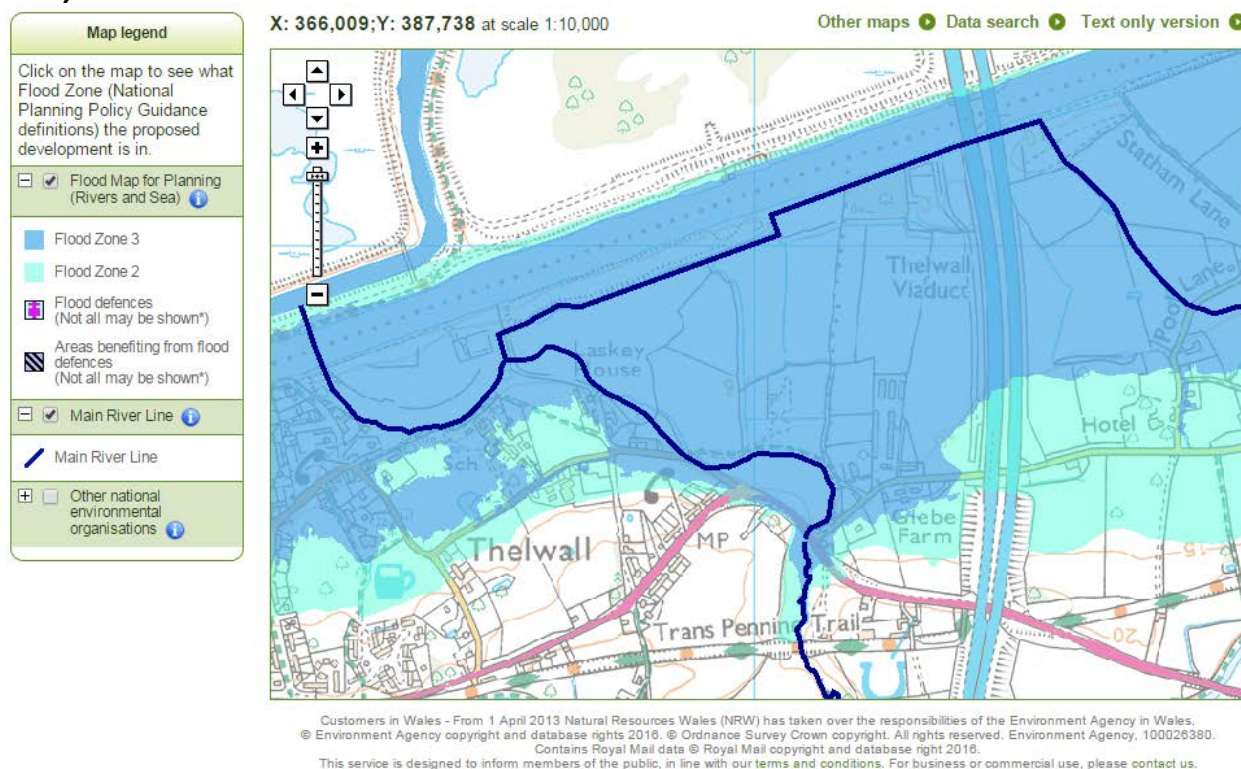
Flood Zone 3 is land assessed as having a 1 in 100 or greater annual probability of river flooding (>1%), or a 1 in 200 or greater annual probability of flooding from the sea (>0.5%) in any year.

Figure 19: Extract of Environment Agency Flood Map for Planning (Rivers and Sea).

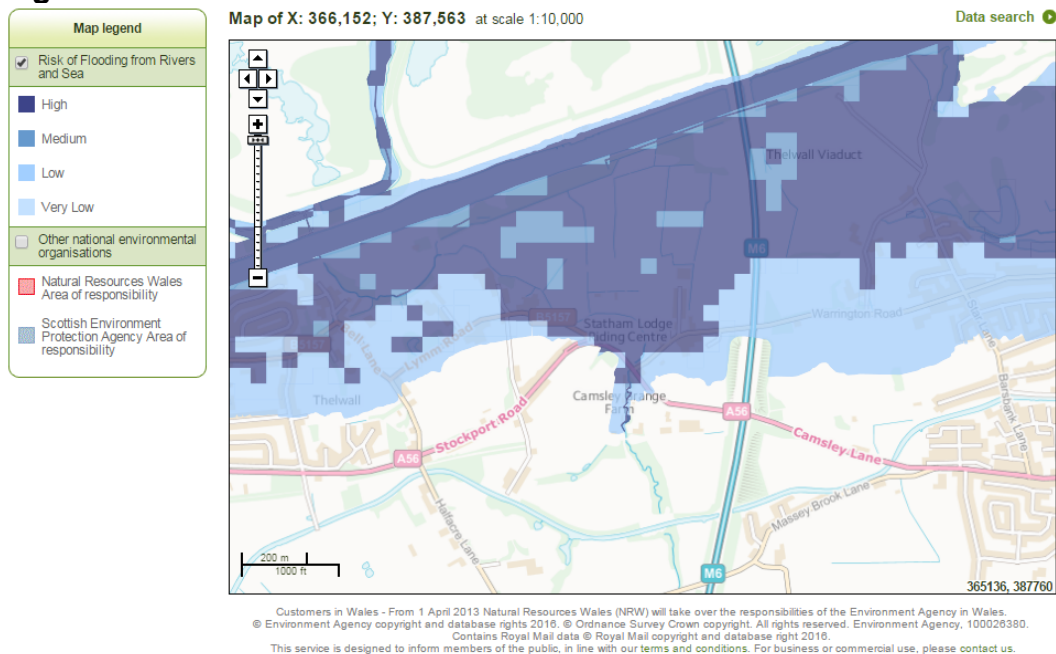
According to the Environment Agency Risk of Flooding from Rivers and Sea Mapping, the area is generally shown as at high/medium risk of flooding. (takes into account of any defences, if present)

Figure 20: Extract of Environment Agency Risk of Flooding from Rivers and Sea Mapping.

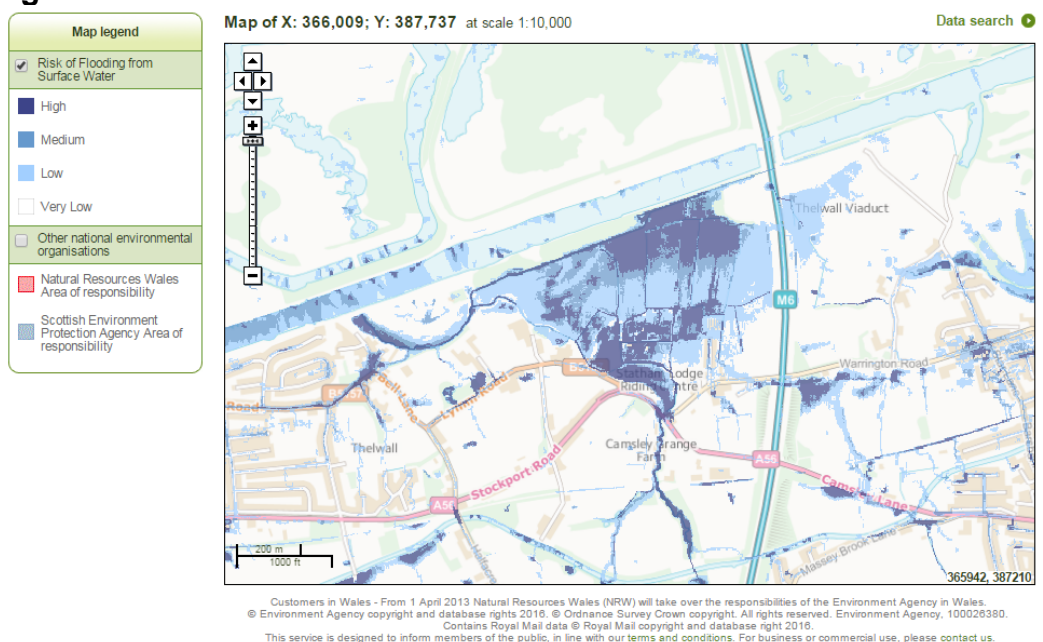
According to the Environment Agency Risk of Flooding from Surface Water mapping, the affected area is generally shown as being at risk of surface water flooding but differing in degrees of risk across the area. The Risk of Flooding from Surface Water Mapping is indicative of low lying areas.

It appears that an area next to the Manchester Ship Canal is shown as at high risk indicating that this is a low area. According to the Environment Agency, this is one of the three breach locations as shown in Figure 3 and on drawing no. LD2016/006/001.

Figure 21: Extract of Environment Agency Risk of Flooding from Surface Water mapping.

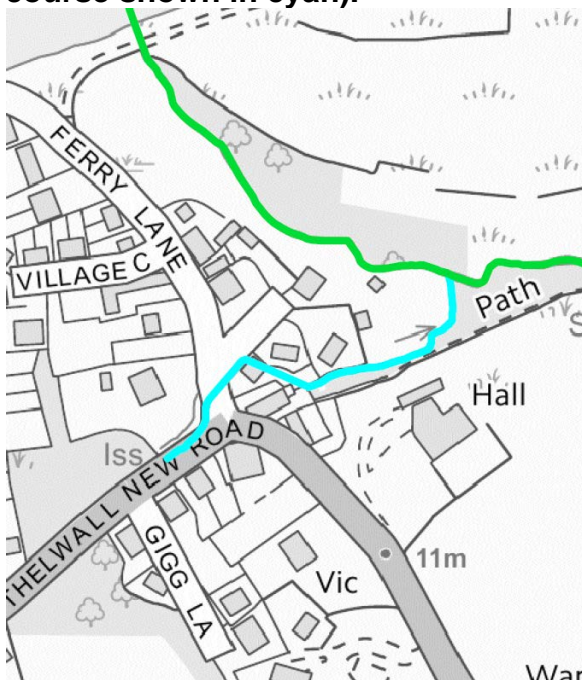
Warrington Borough Council received a number of complaints regarding the condition of the ordinary watercourse (tributary to Thelwall Brook) shown as a cyan line in figure 22 below.

Figure 22: Screenshot of Watercourse Classification Plan (Main river shown in green, ordinary watercourse shown in cyan).

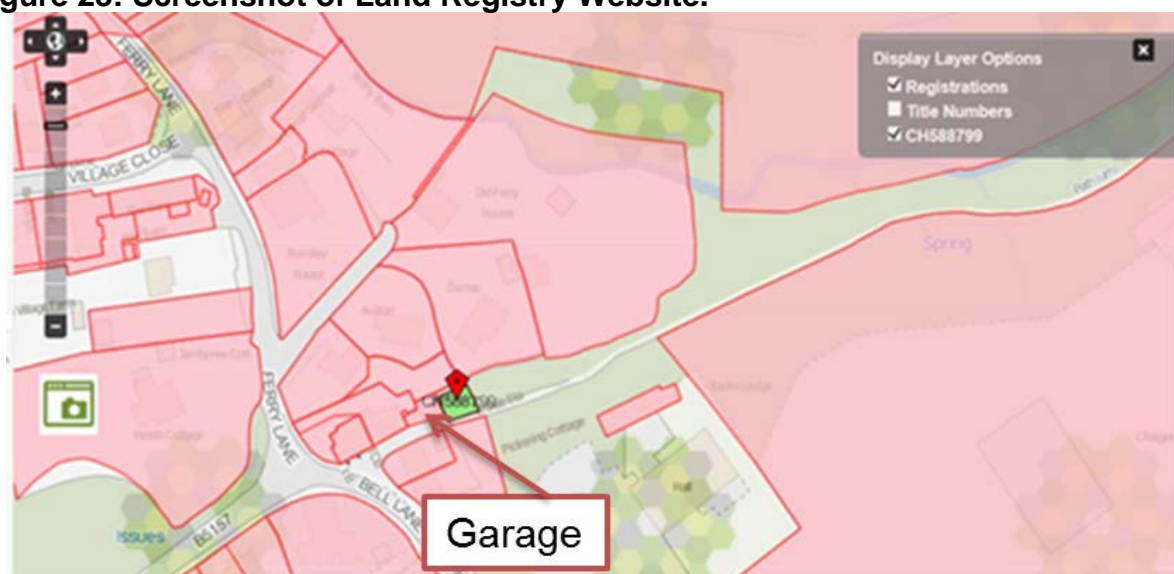
It appears that the land to the north of the ordinary watercourse which runs in an east to west direction from the outfall behind the garage to the east of Post Office Cottage is registered. The landowners are presumed to be the riparian owners to the centreline of the watercourse.

Figure 23: Screenshot of Land Registry Website.

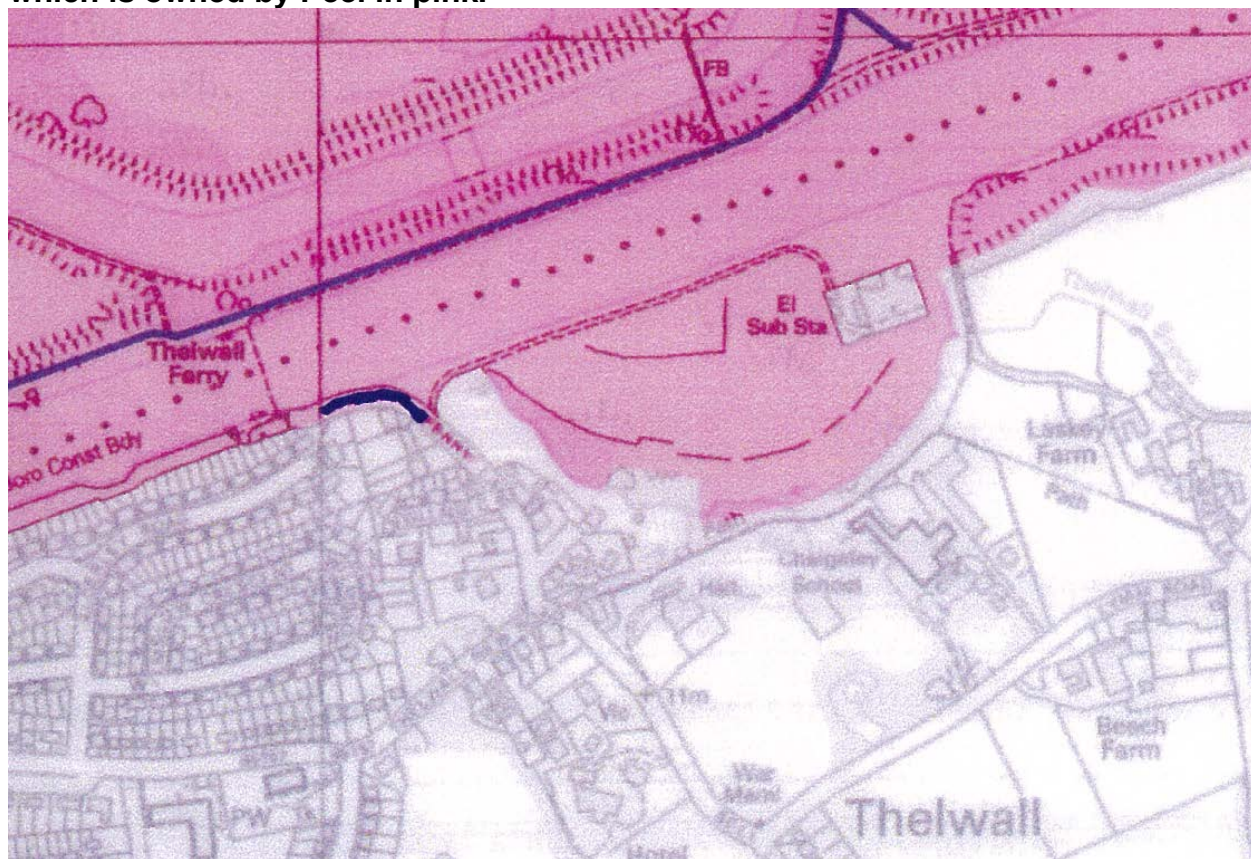
Deposit reference: 31A02011004 was made by Peel Investments (North) Limited of Peel Dome on 21 April 2011. See figure 24 for an extract of the map showing the limit of their land ownership. It appears that Peel Investments do not own the land to the southern side of the ordinary watercourse.

Figure 24: Extract of deposit reference 31A02011004 map showing the land which is owned by Peel in pink.

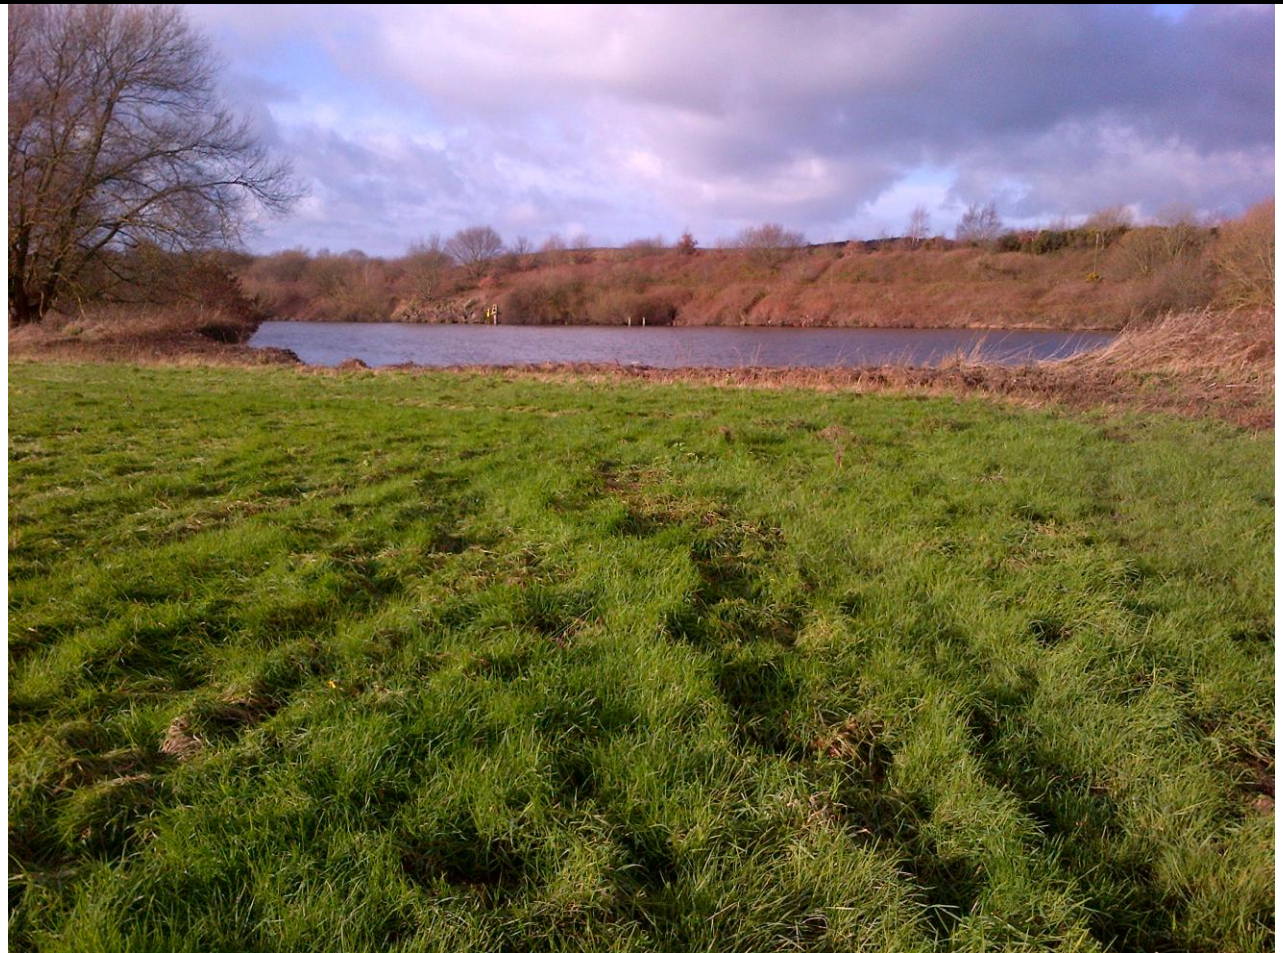
Photo 1. One of the embankment low spots. From SJ6700088350, view N. 14/01/16.
